Research Stations and life in the cold

Need to overcome three things in Antarctica:

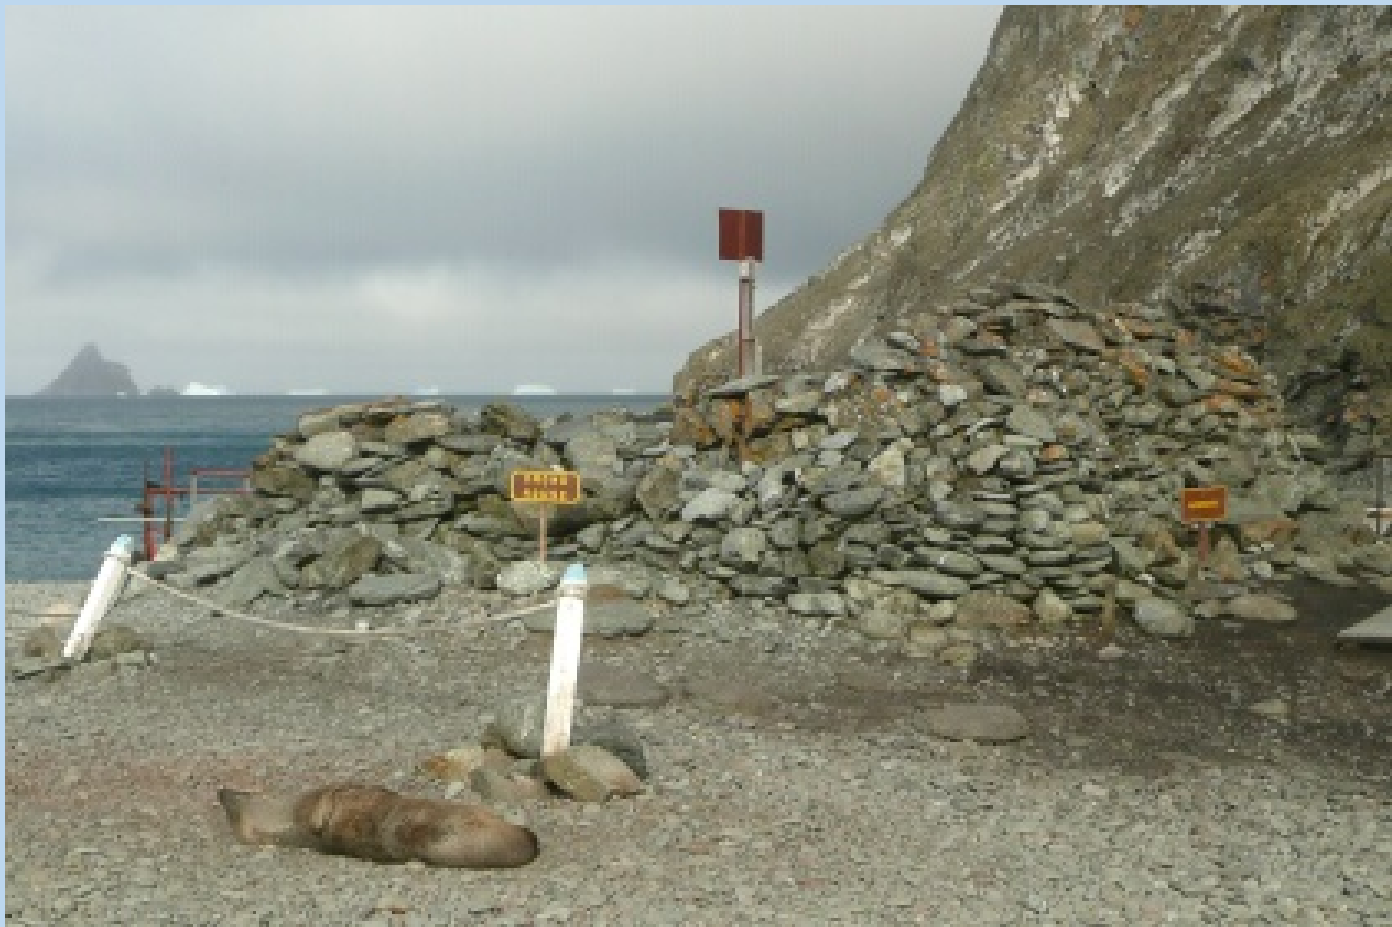
The first research station was a stone hut built in 1902 by William Bruce on Laurie Island, South Orkneys, as part of the Scottish National Antarctic Expedition

Established as a meteorological station, base for exploring the islands

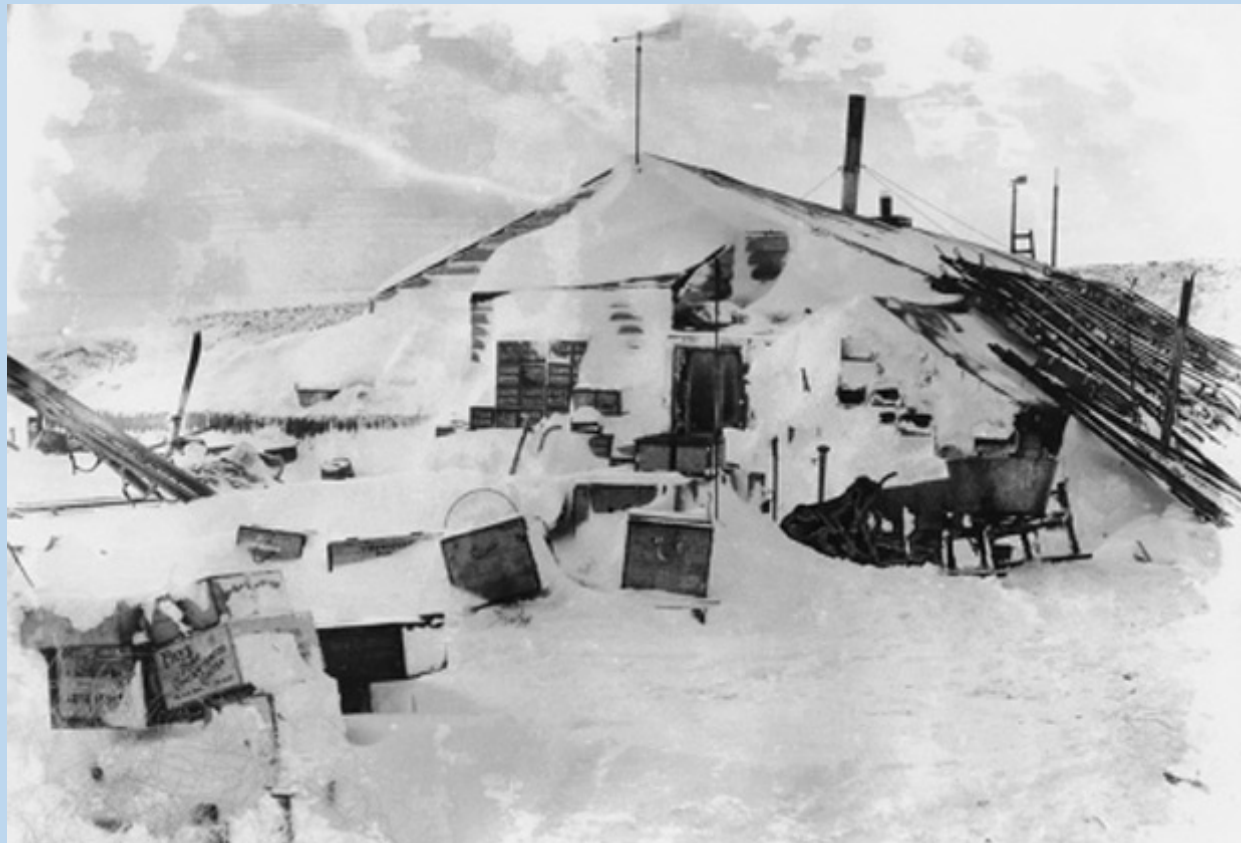
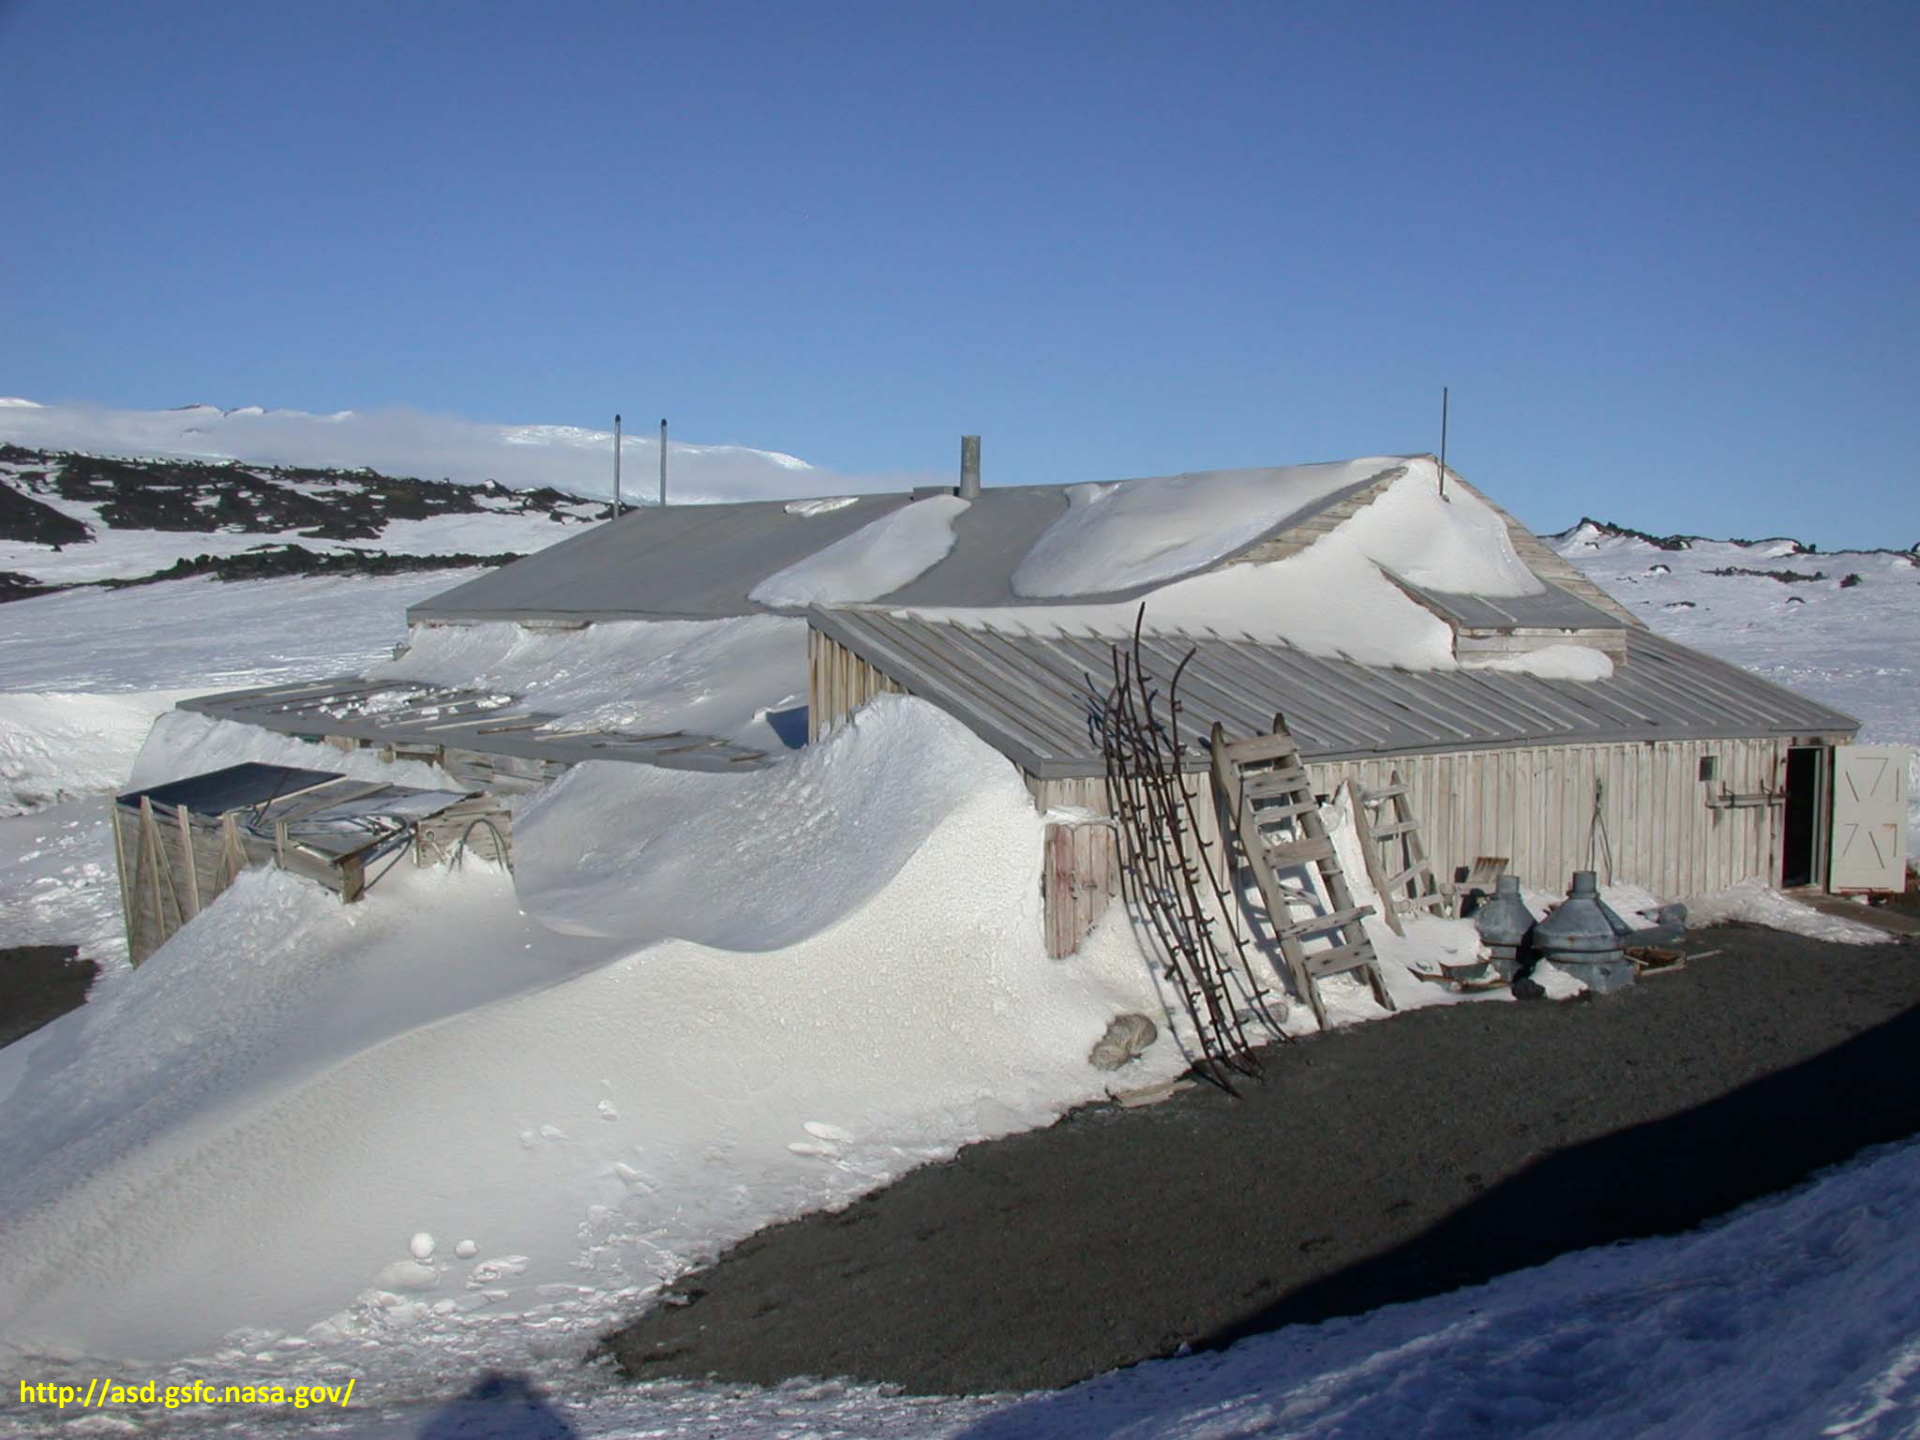
Pre-fabricated for rapid construction, durable, but not always very comfortable

Wind, snow would seep through cracks and snow would blow and collect on the leeward side or the roof and never melt

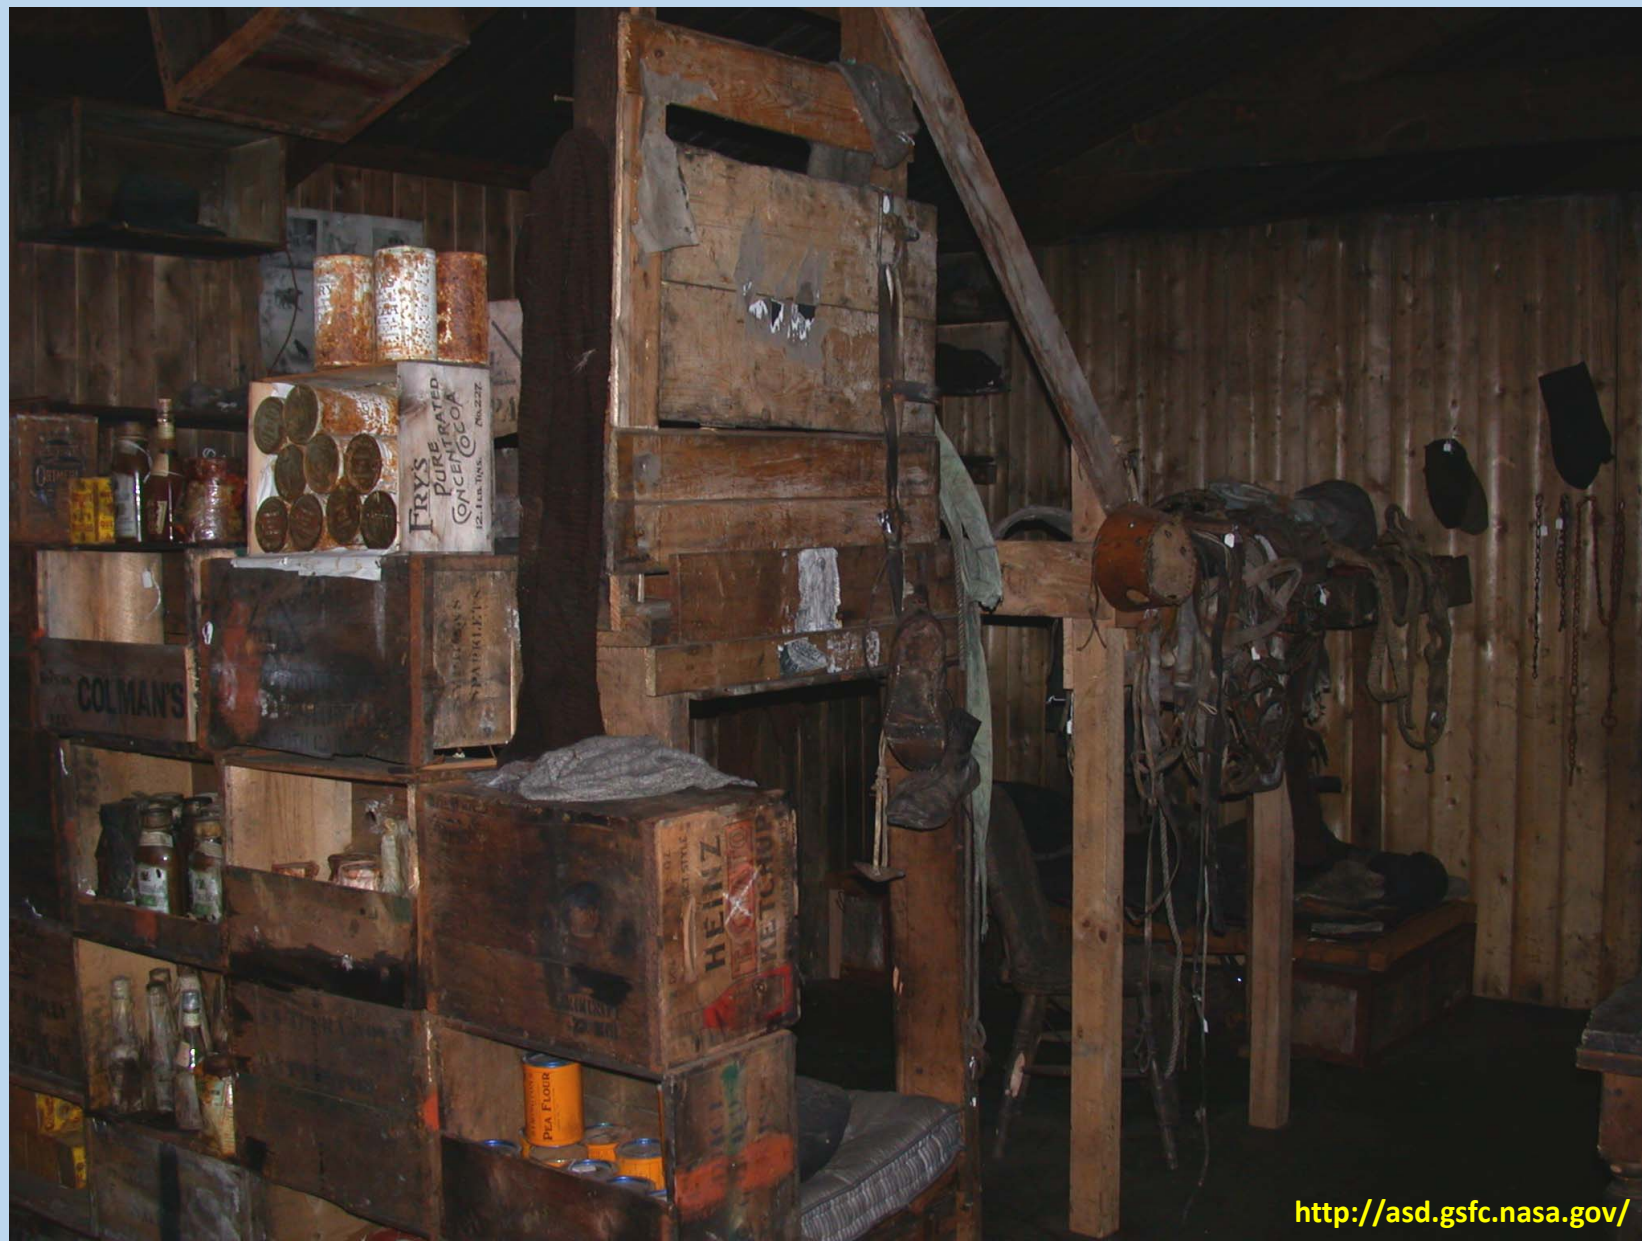
The Cape Evans hut was separated into three areas: officer's quarters, enlisted quarters, and a work area. There also was a dark room where the photographer, Herbert Ponting, worked and slept

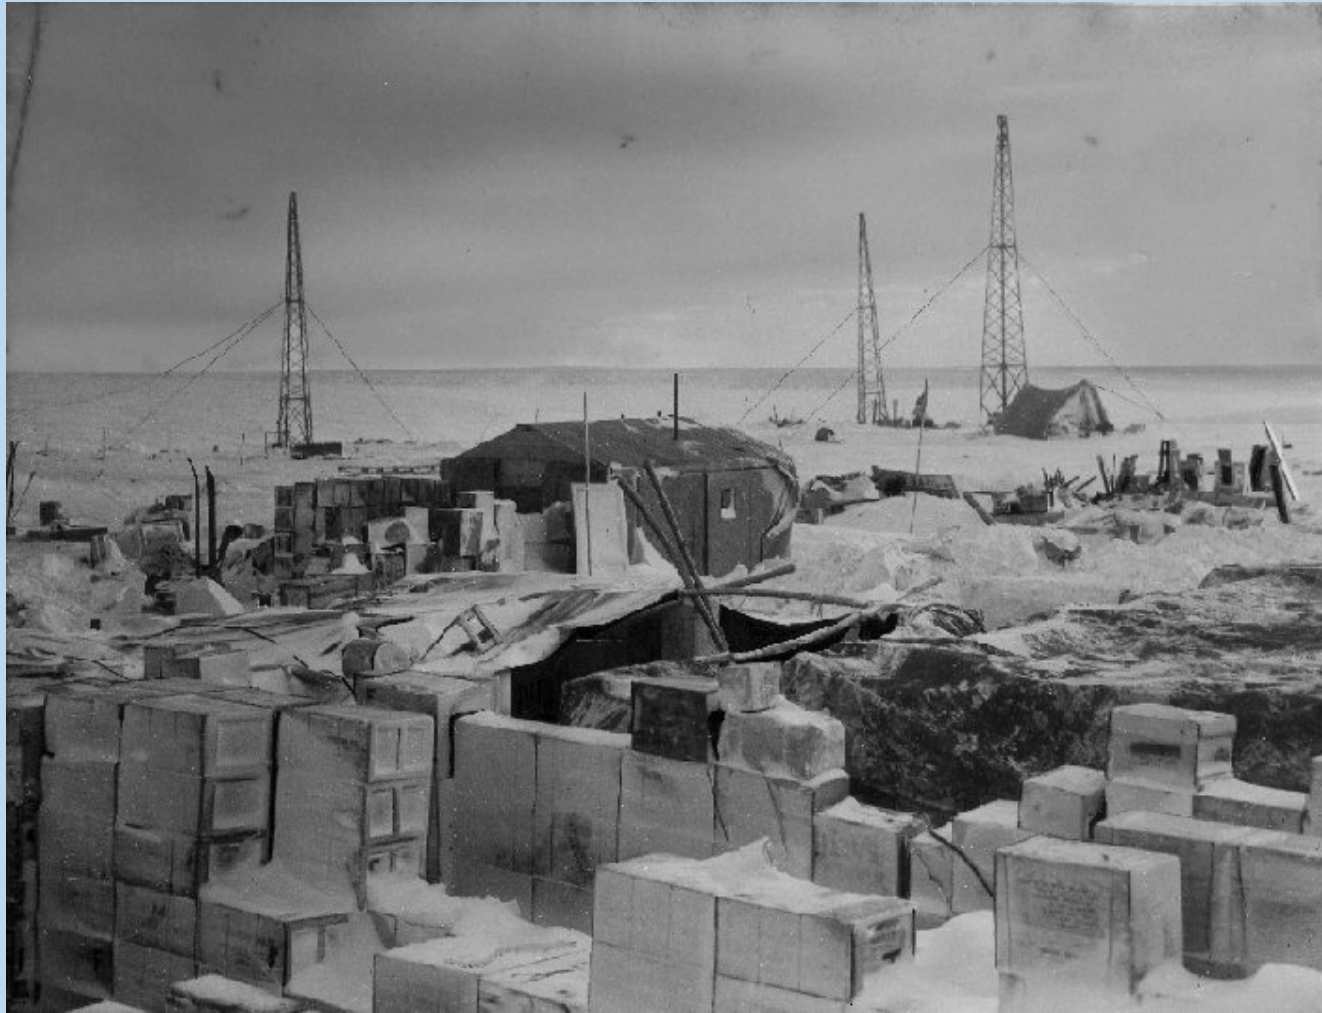
Little America was the first, built in 1929 on the Ross Ice Shelf, went through five iterations by 1956 with Richard Byrd's expeditions

The first included three radio towers and the main hut

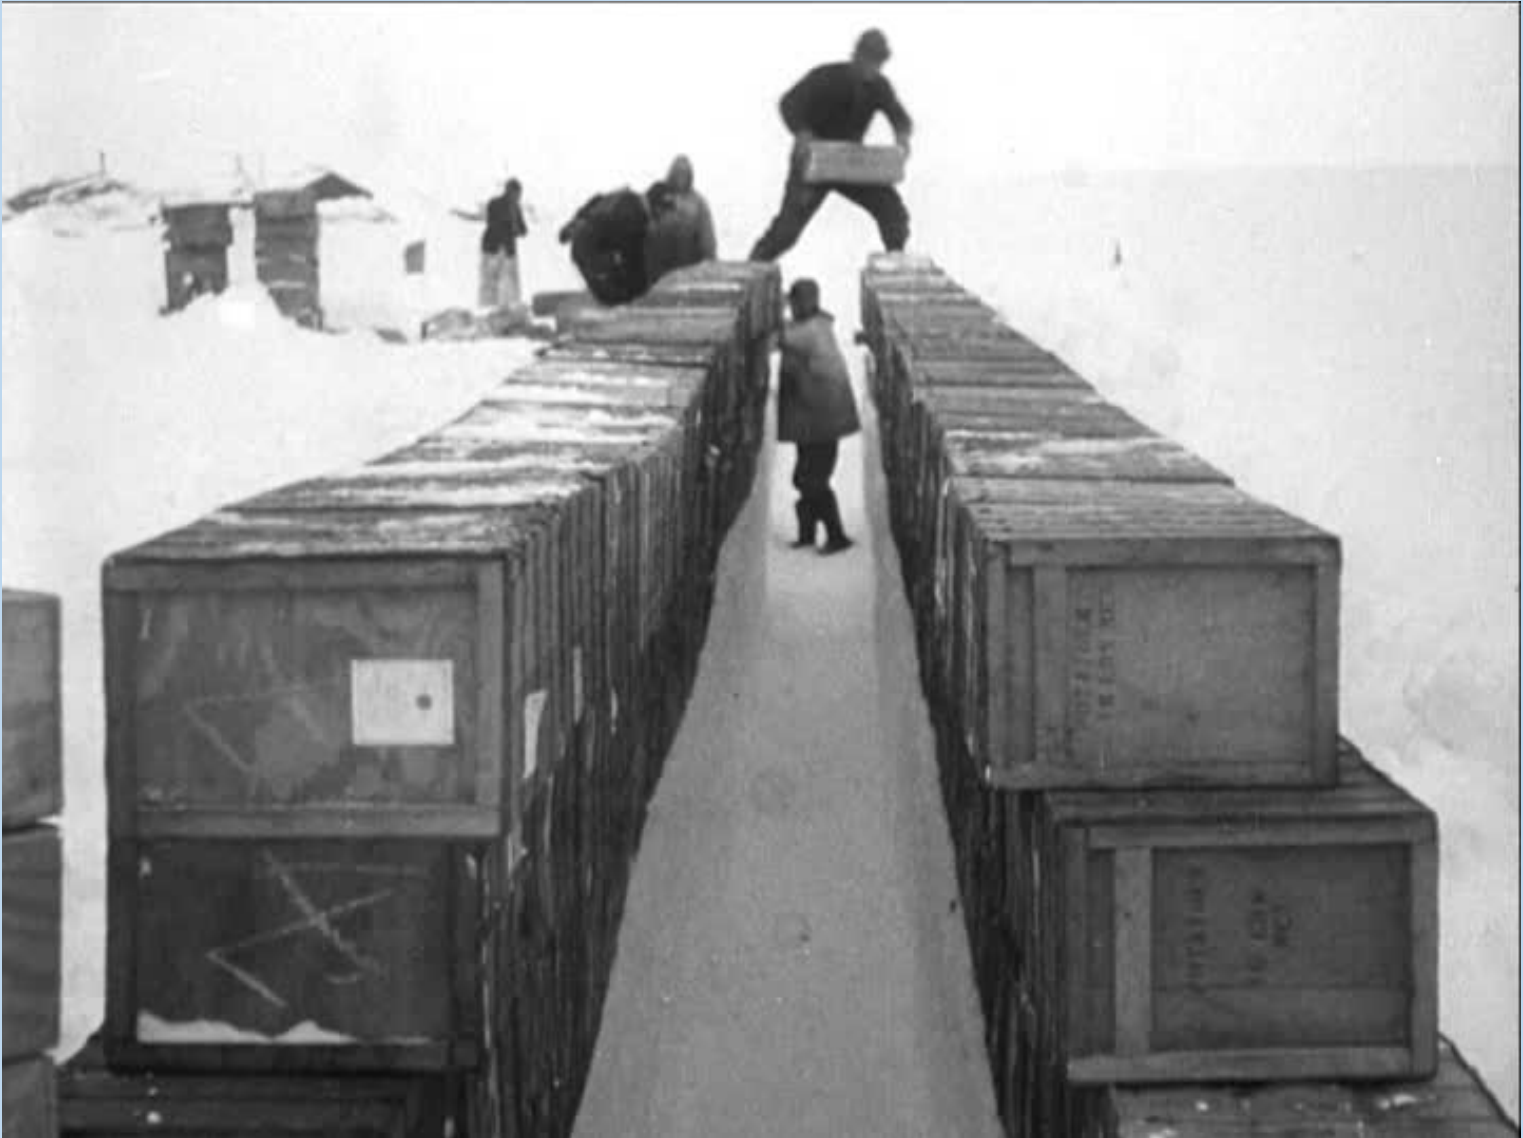
They used wooden crates to construct tunnels between buildings

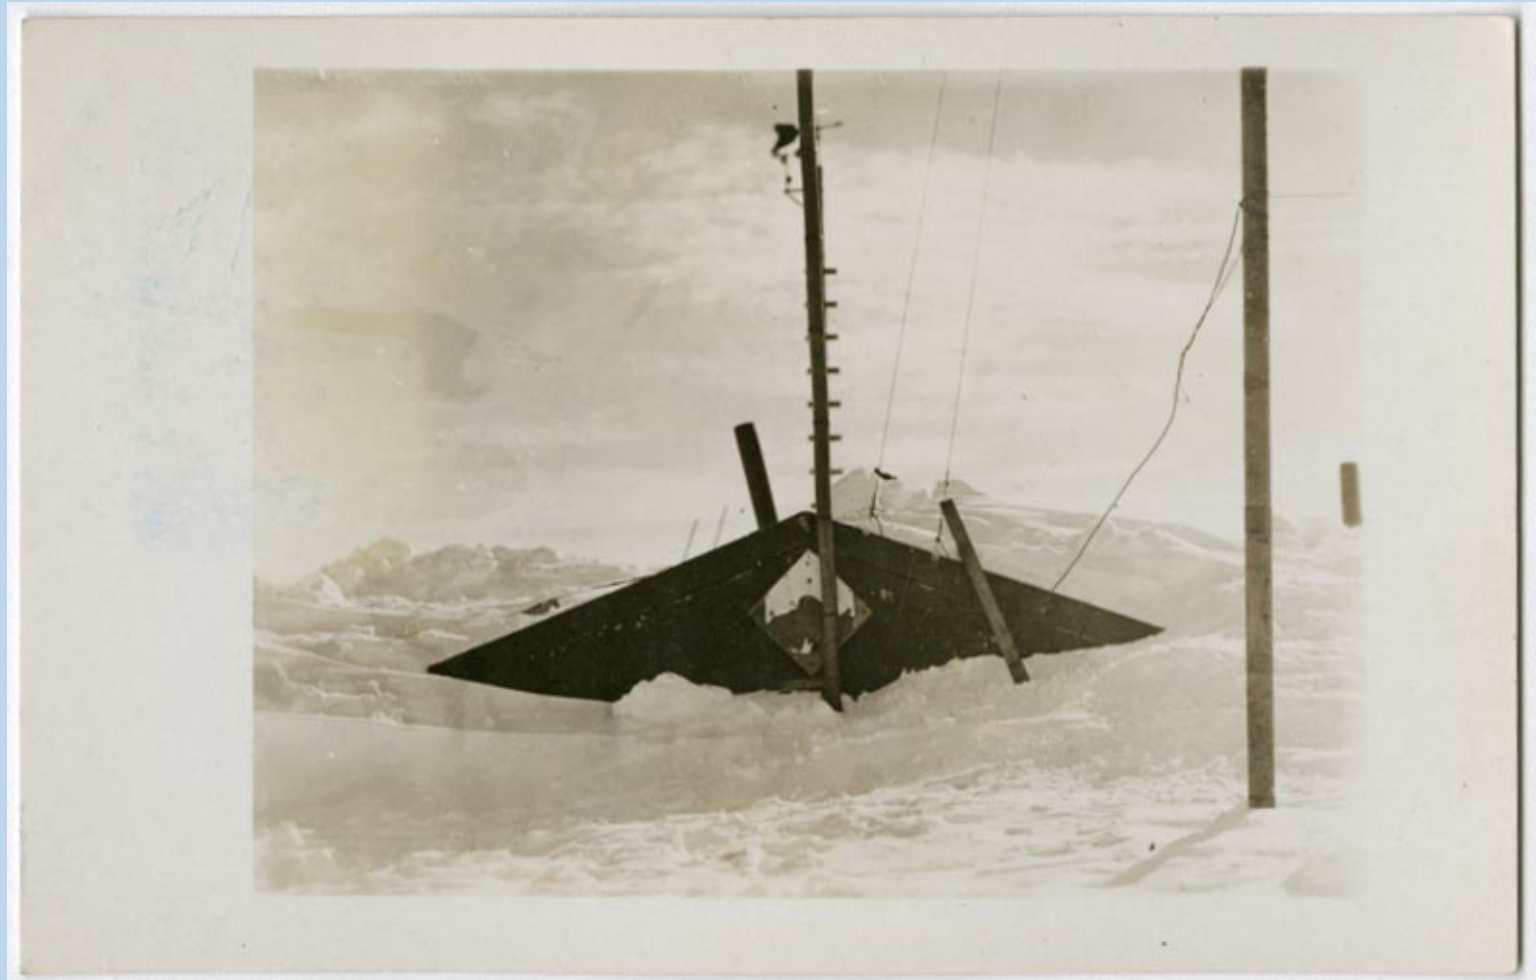
Over time, gradual snow accumulation and melting from the darker color of the station caused it to sink into the ice shelf

This also caused ventilation problems, possibility of carbon monoxide poisoning from heating systems

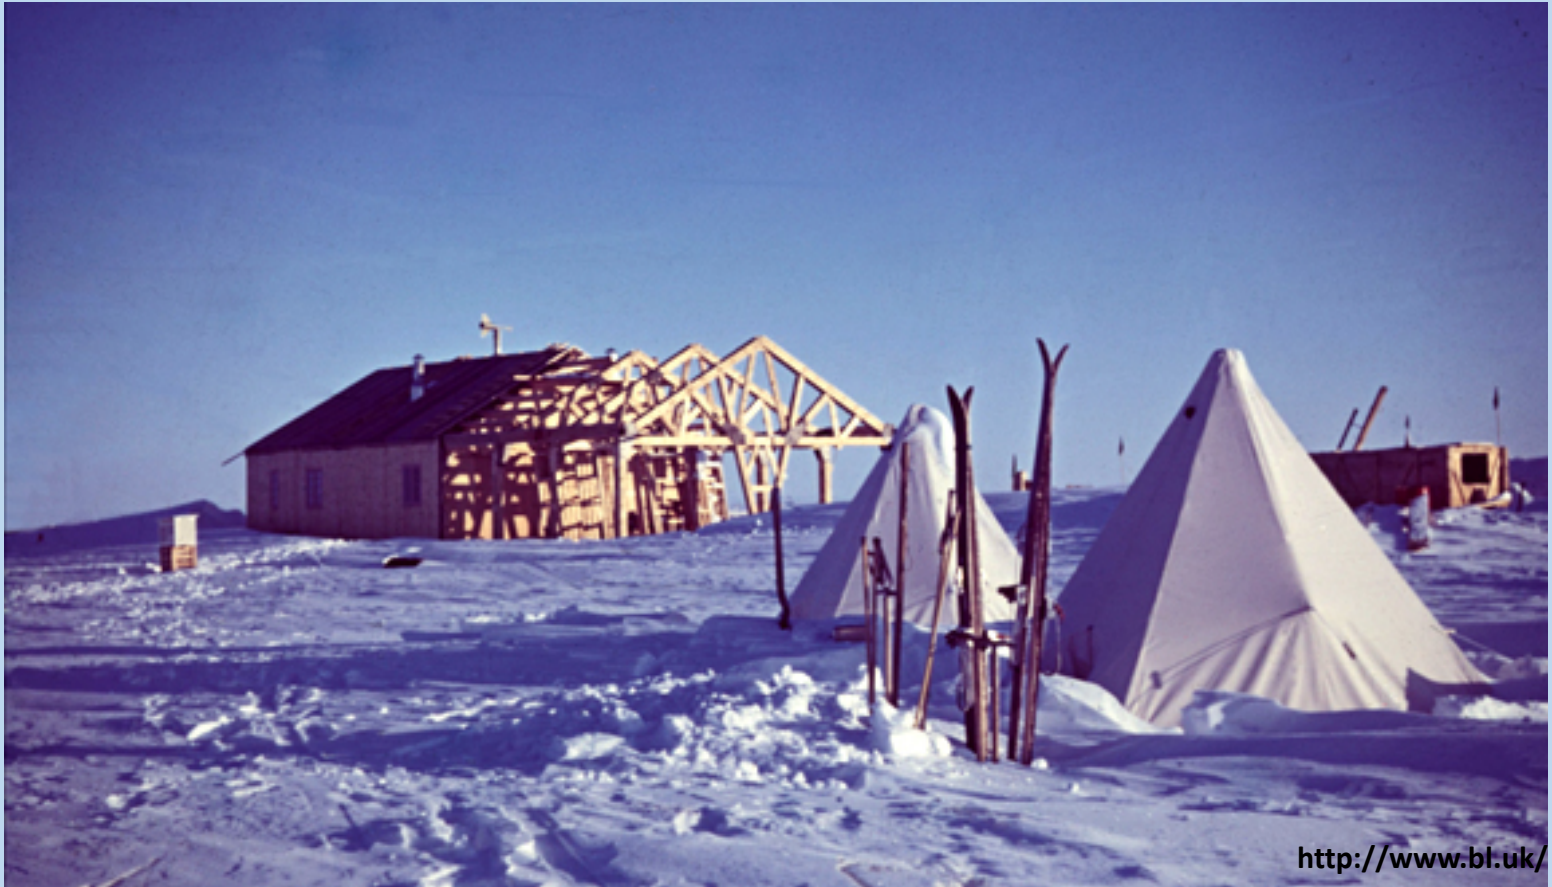
Halley Station (U.K.) built in 1956 for the IGY in 1957-1958 on the Brunt Ice Shelf in the Weddell Sea

Originally a wood structure, it was engulfed by snow accumulation and abandoned by 1963

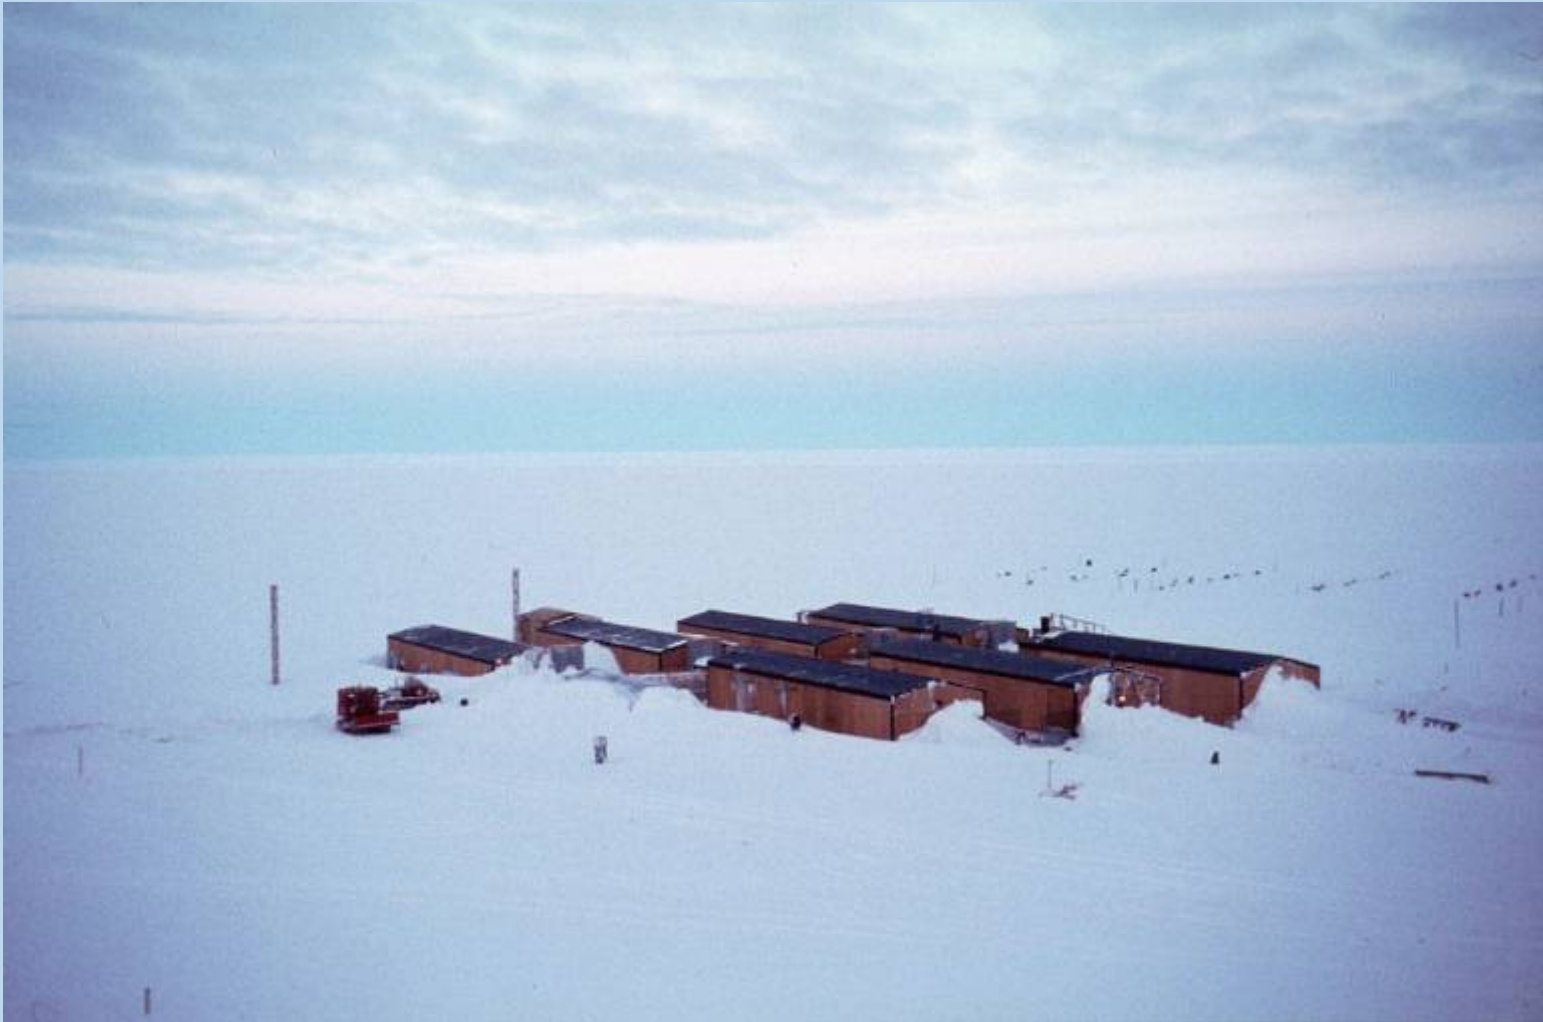
Halley II drawing about 10 years after construction

Subsequent structures ranged from surface buildings with steel roof supports (Halley II), to subsurface steel tubing (Halley III), but these also had to be abandoned

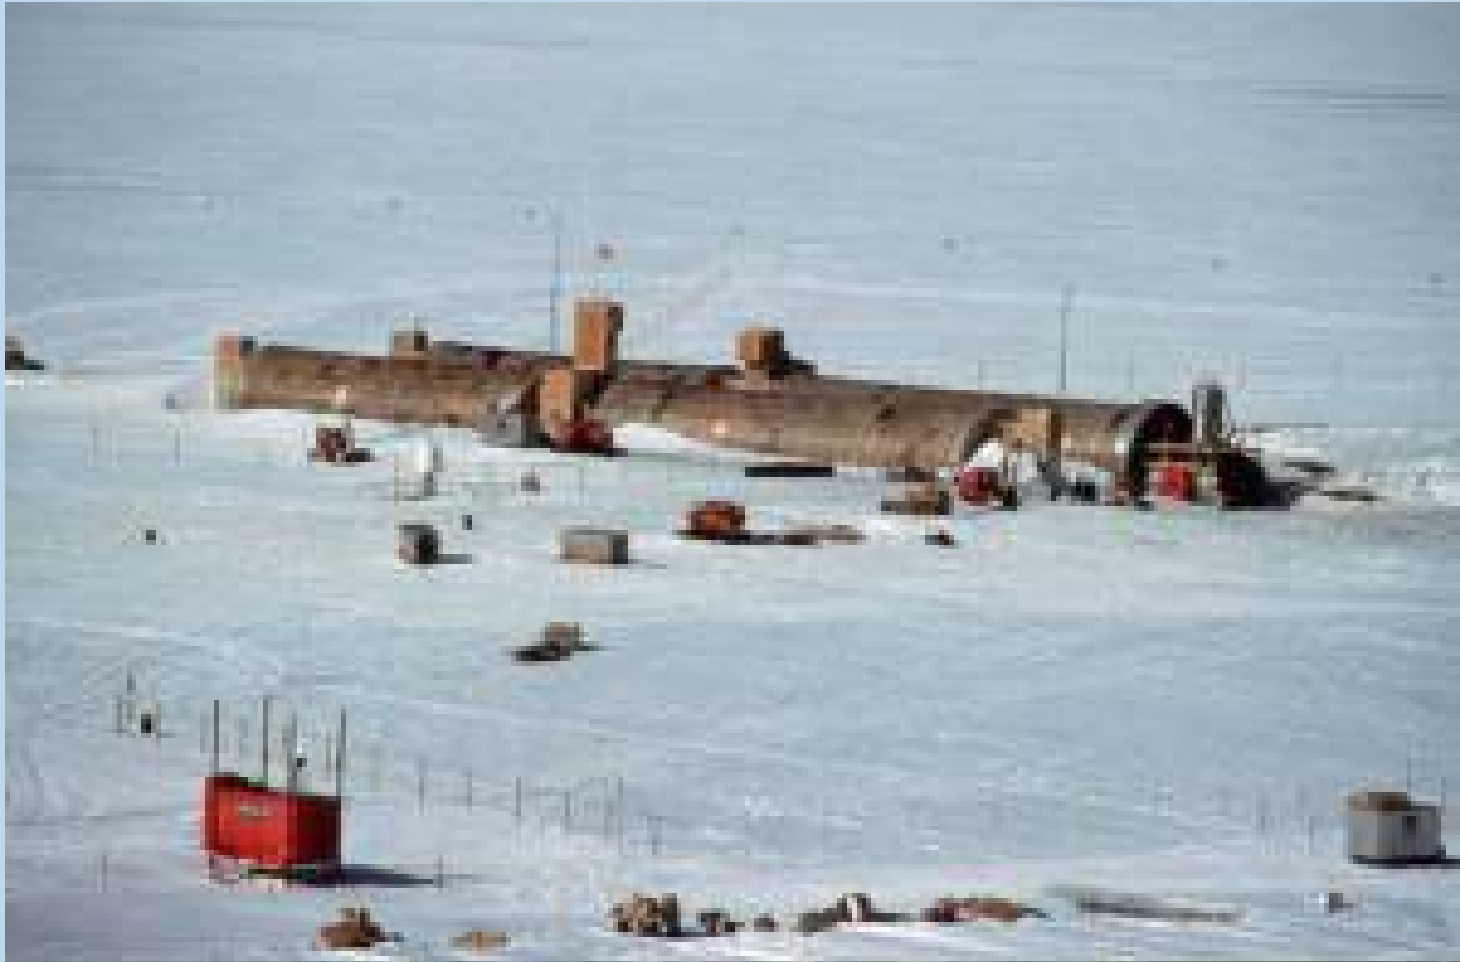
Halley IV built in 1983 with curved roof, but still had snow drift piling up and blocking windows, vents. Abandoned after nine years

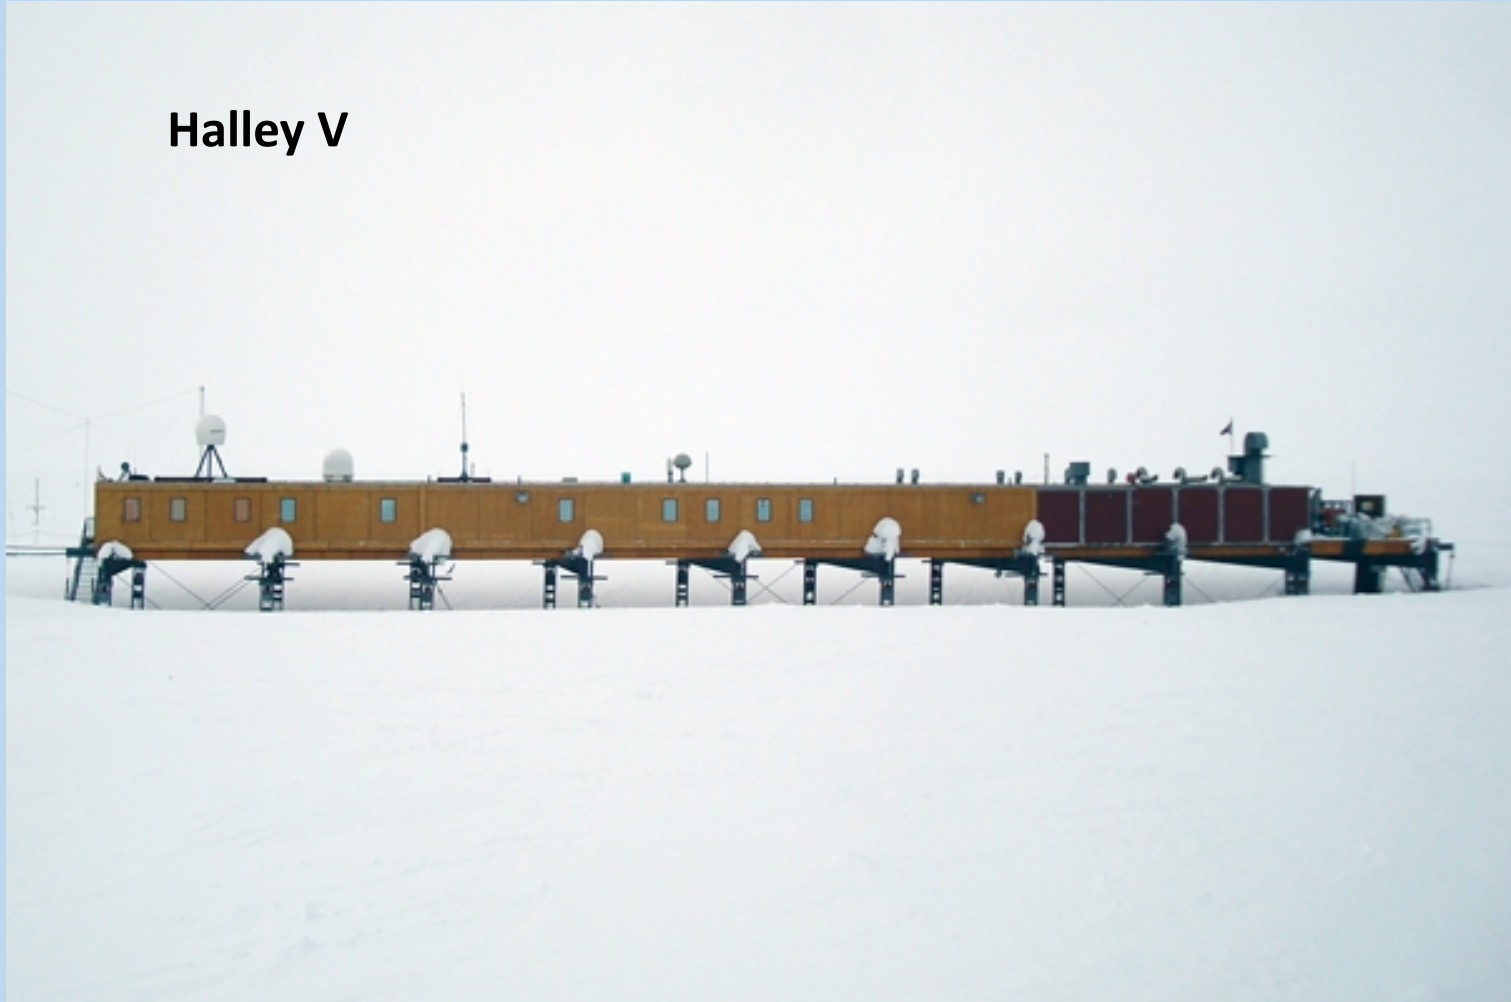
Halley V

Then it was built on jackable steel stilts, so it could be raised above the drift, but it was fixed to a moving ice shelf and eventually had to be abandoned as it approached the edge

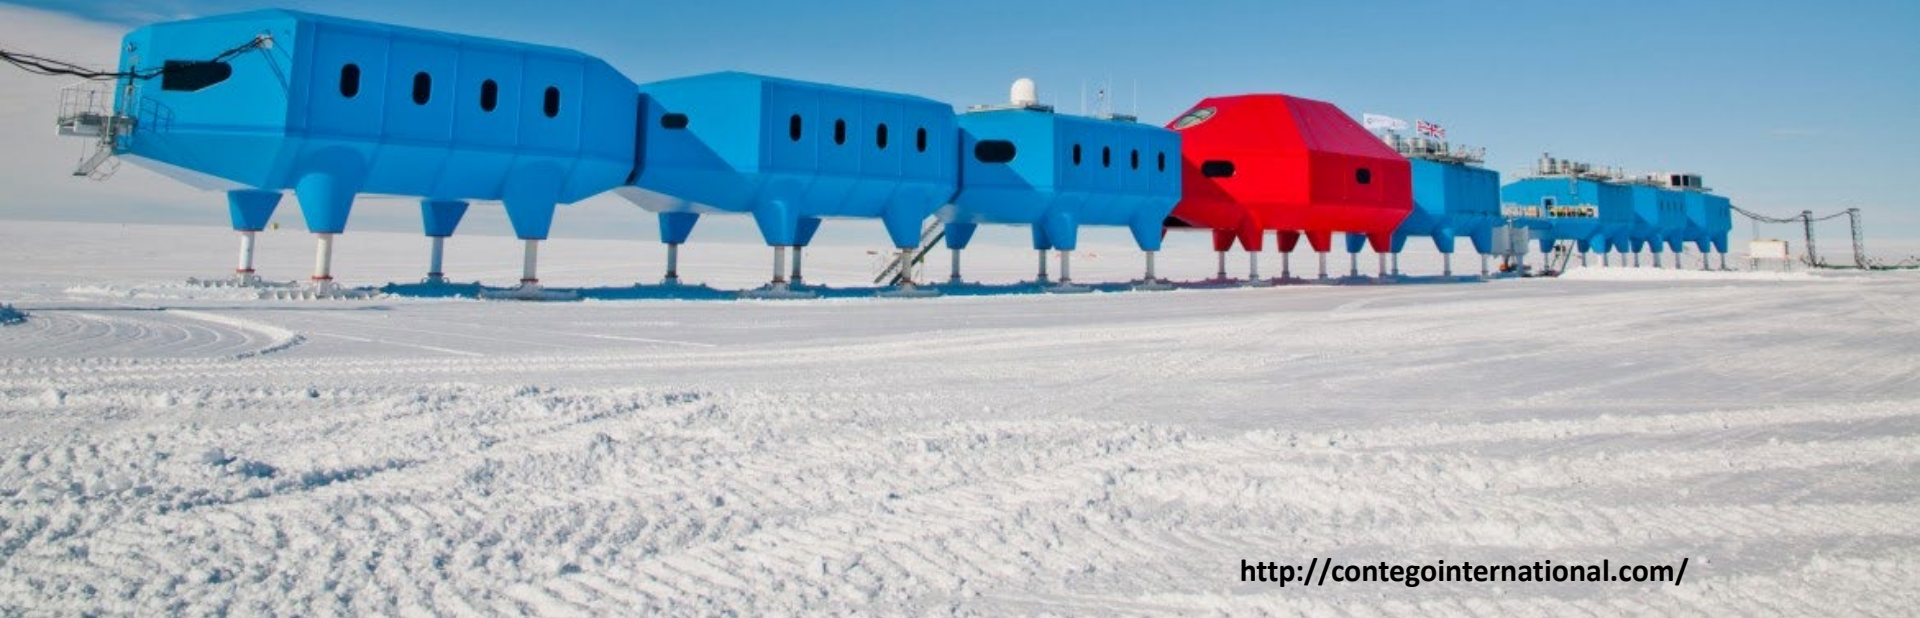
Halley VI

It is currently on its sixth iteration—2013 built on stilt skis, so it can be moved in sections when needed

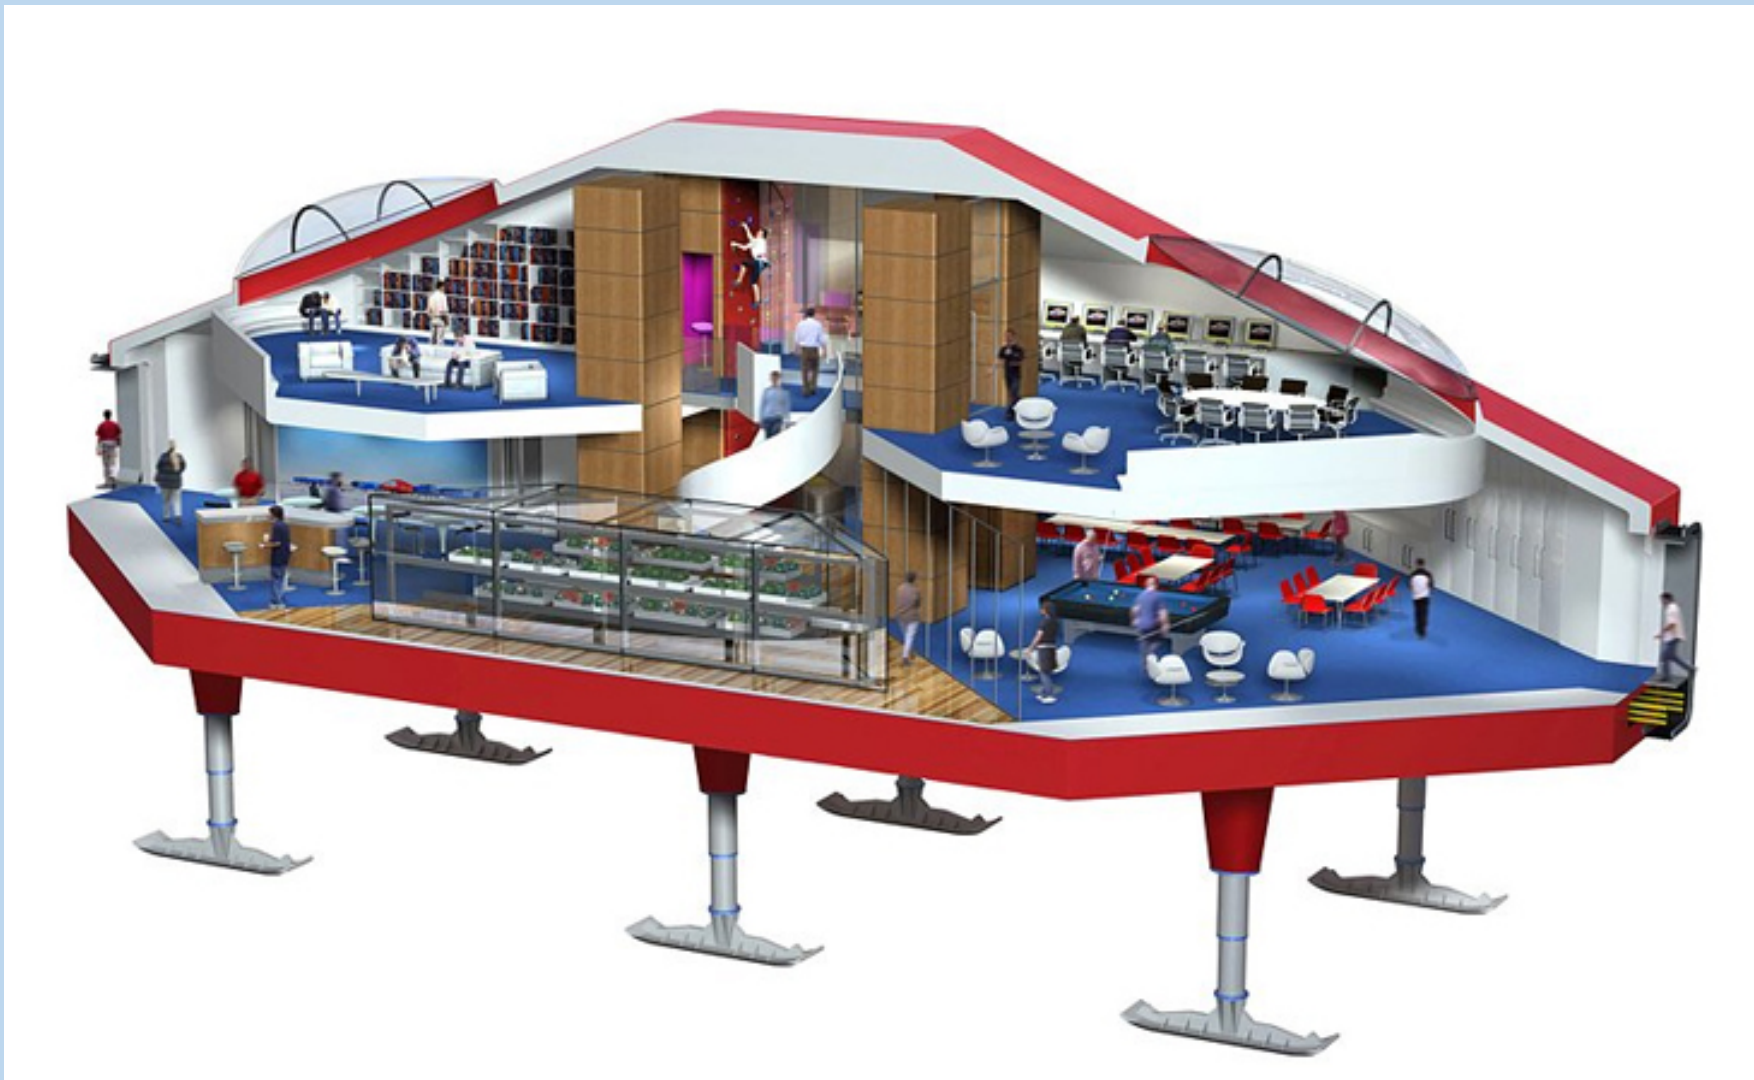
HALLEY VI RESEARCH STATION - Brunt Ice Shelf, Antarctica

satellite image acquired 25th October 2017

After completion, ice chasm became more active, threatening station

Halley VI had to be moved in the 2016-2017 season due to large crack in ice shelf extending towards it

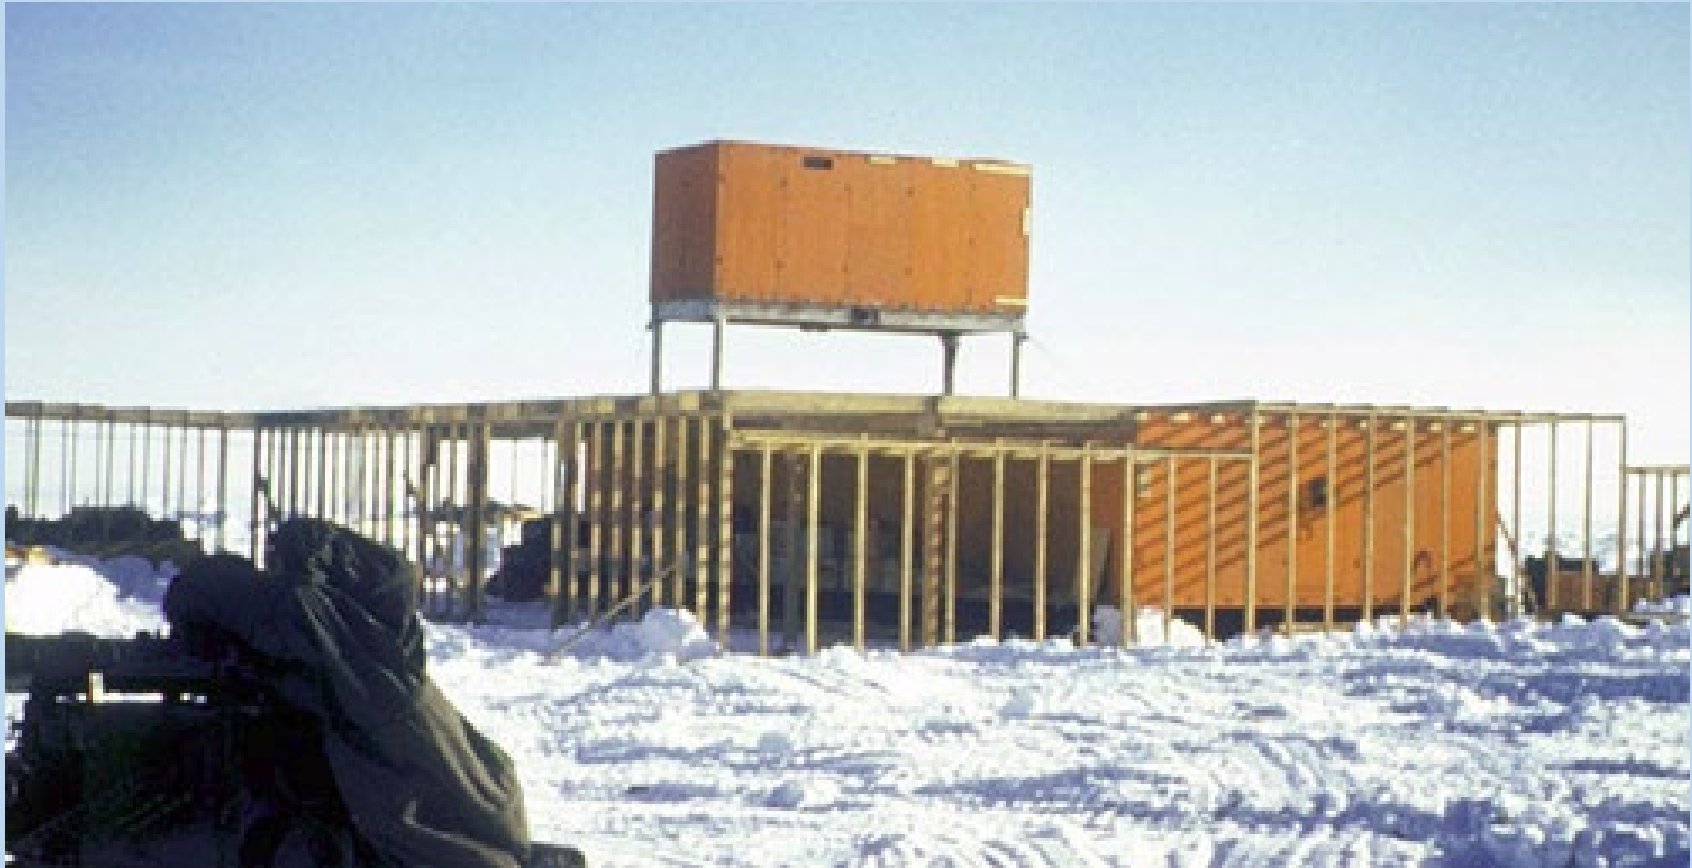
Anticipating snow accumulation, the base was built from wood in two stories, so the upper story would be at ground level in the future
