Research Stations and life in the cold

Need to overcome three things in Antarctica:

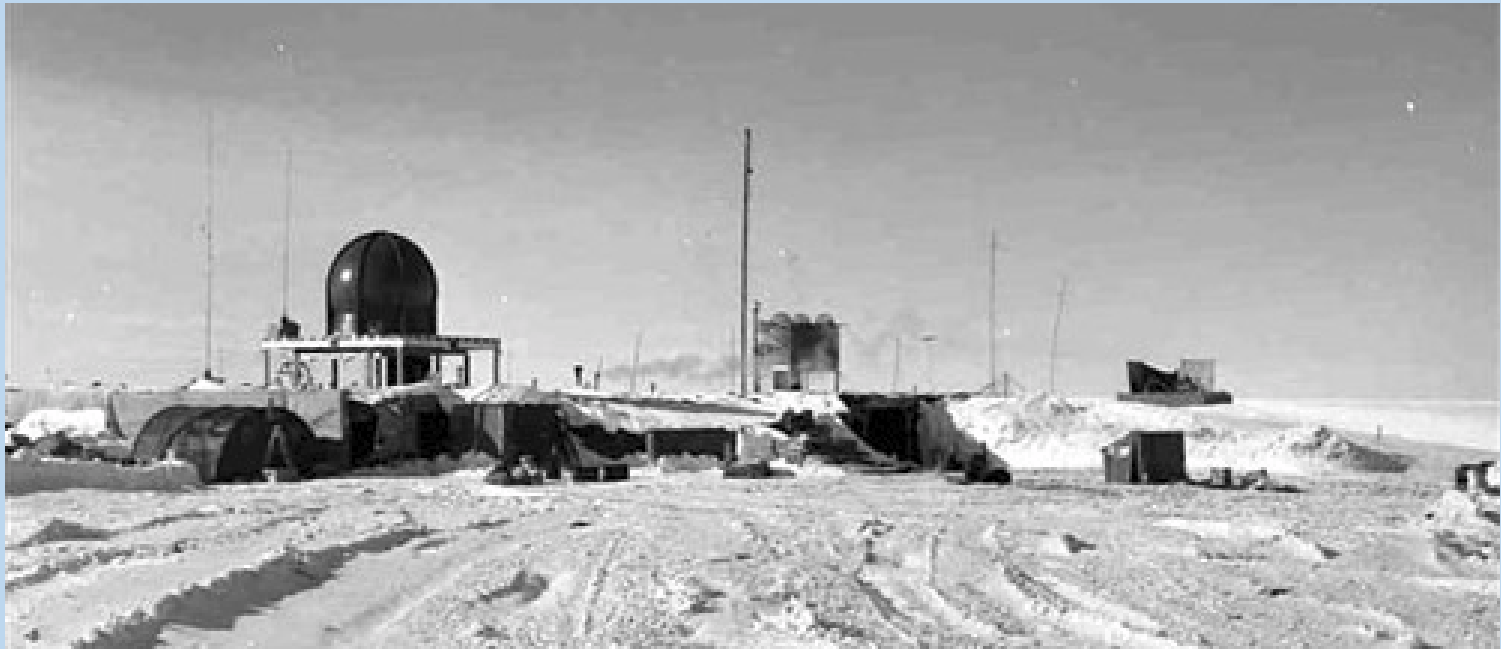
Original South Pole Station in 1957, built by the U.S. Navy

It eventually was buried by snow accumulation and drift and was abandoned in 1975

Anticipating snow accumulation, the base was built from wood in two stories, so the upper story would be at ground level in the future

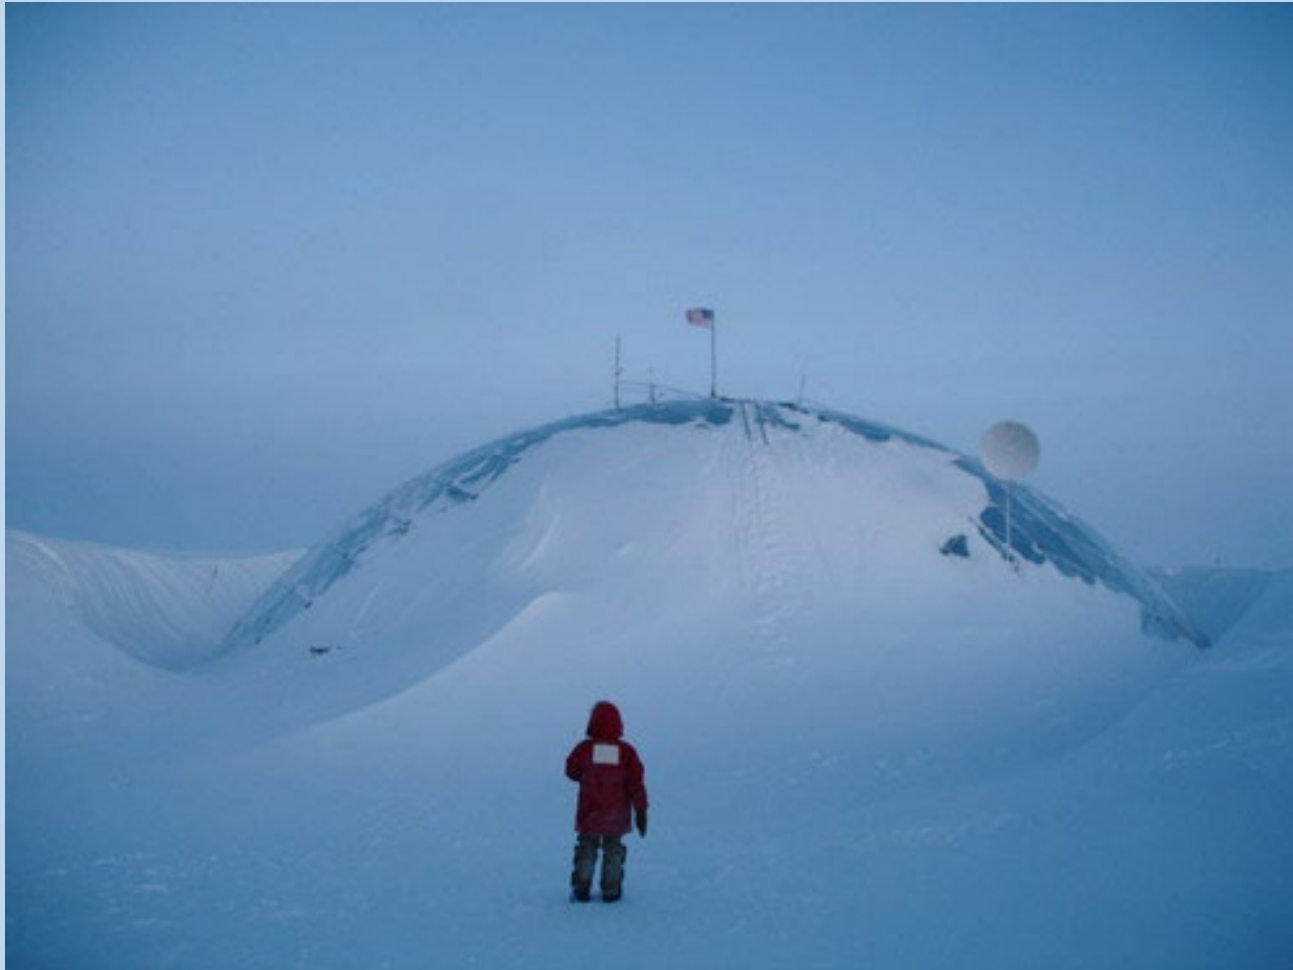
Next, a large dome was built with aluminum panels and used as a protective bubble for buildings inside

Still had problems with snow and condensation and ice inside the dome

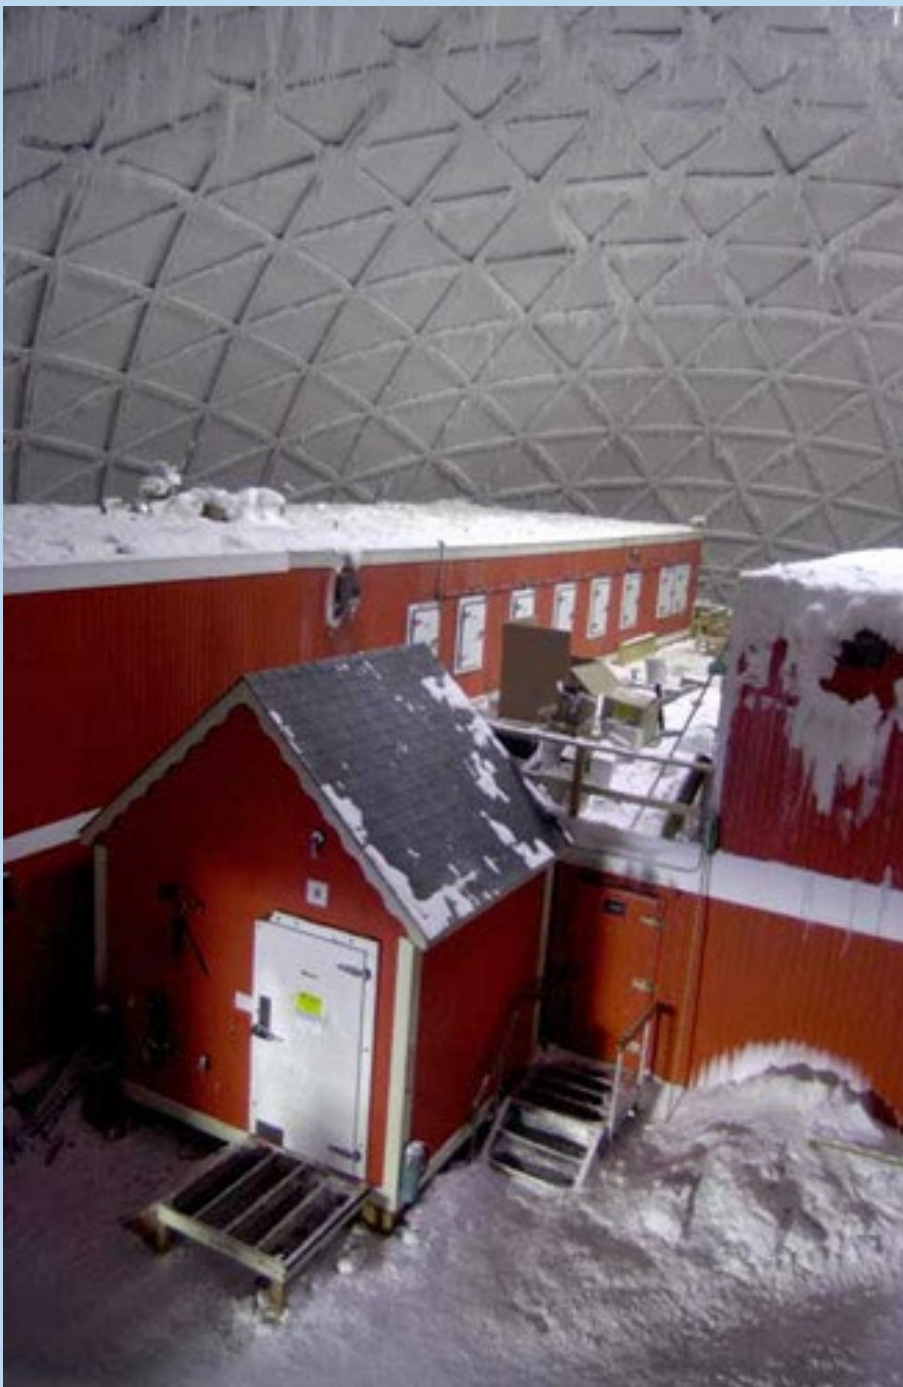
It was removed during construction of the new base in 2009-2010

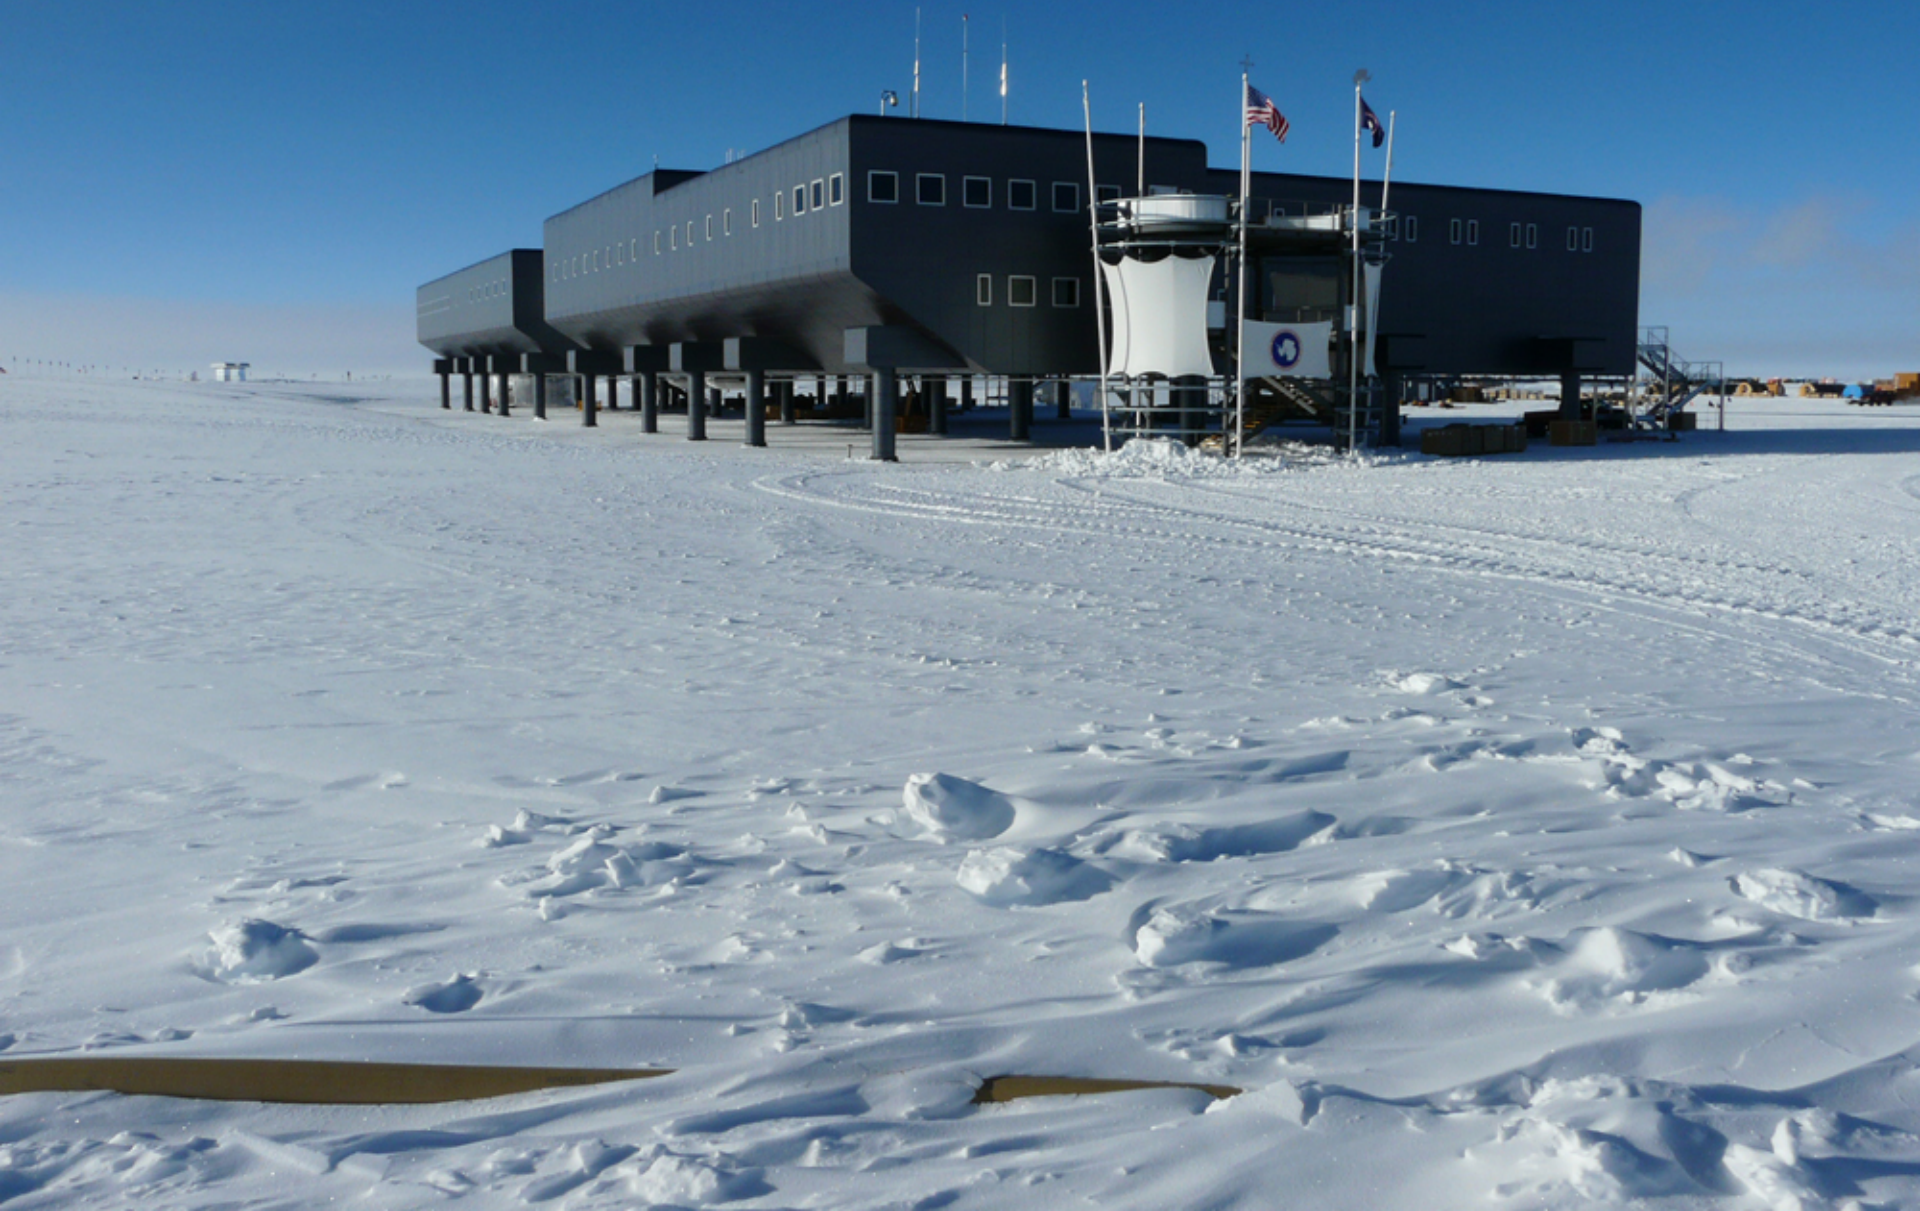
The new station also is built on jackable steel supports, snow blows under it and it can be raised several stories as it sinks

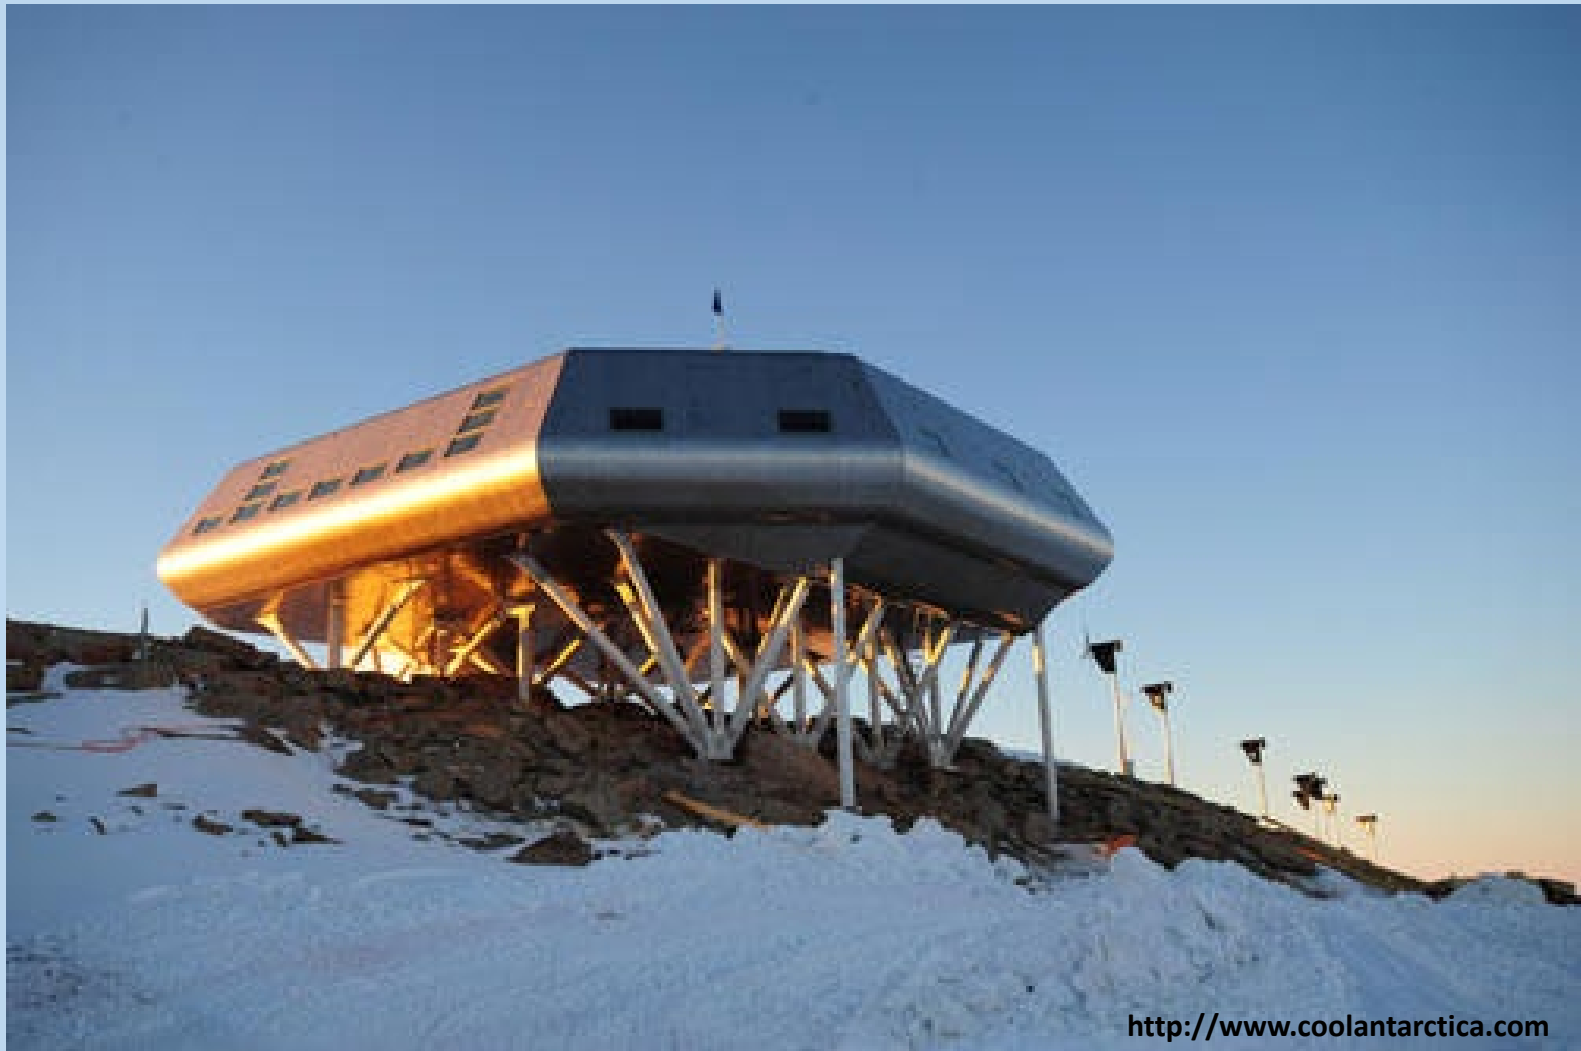
Aerodynamic shape faces wind, stilts prevent snow accumulation and allows melt water drainage

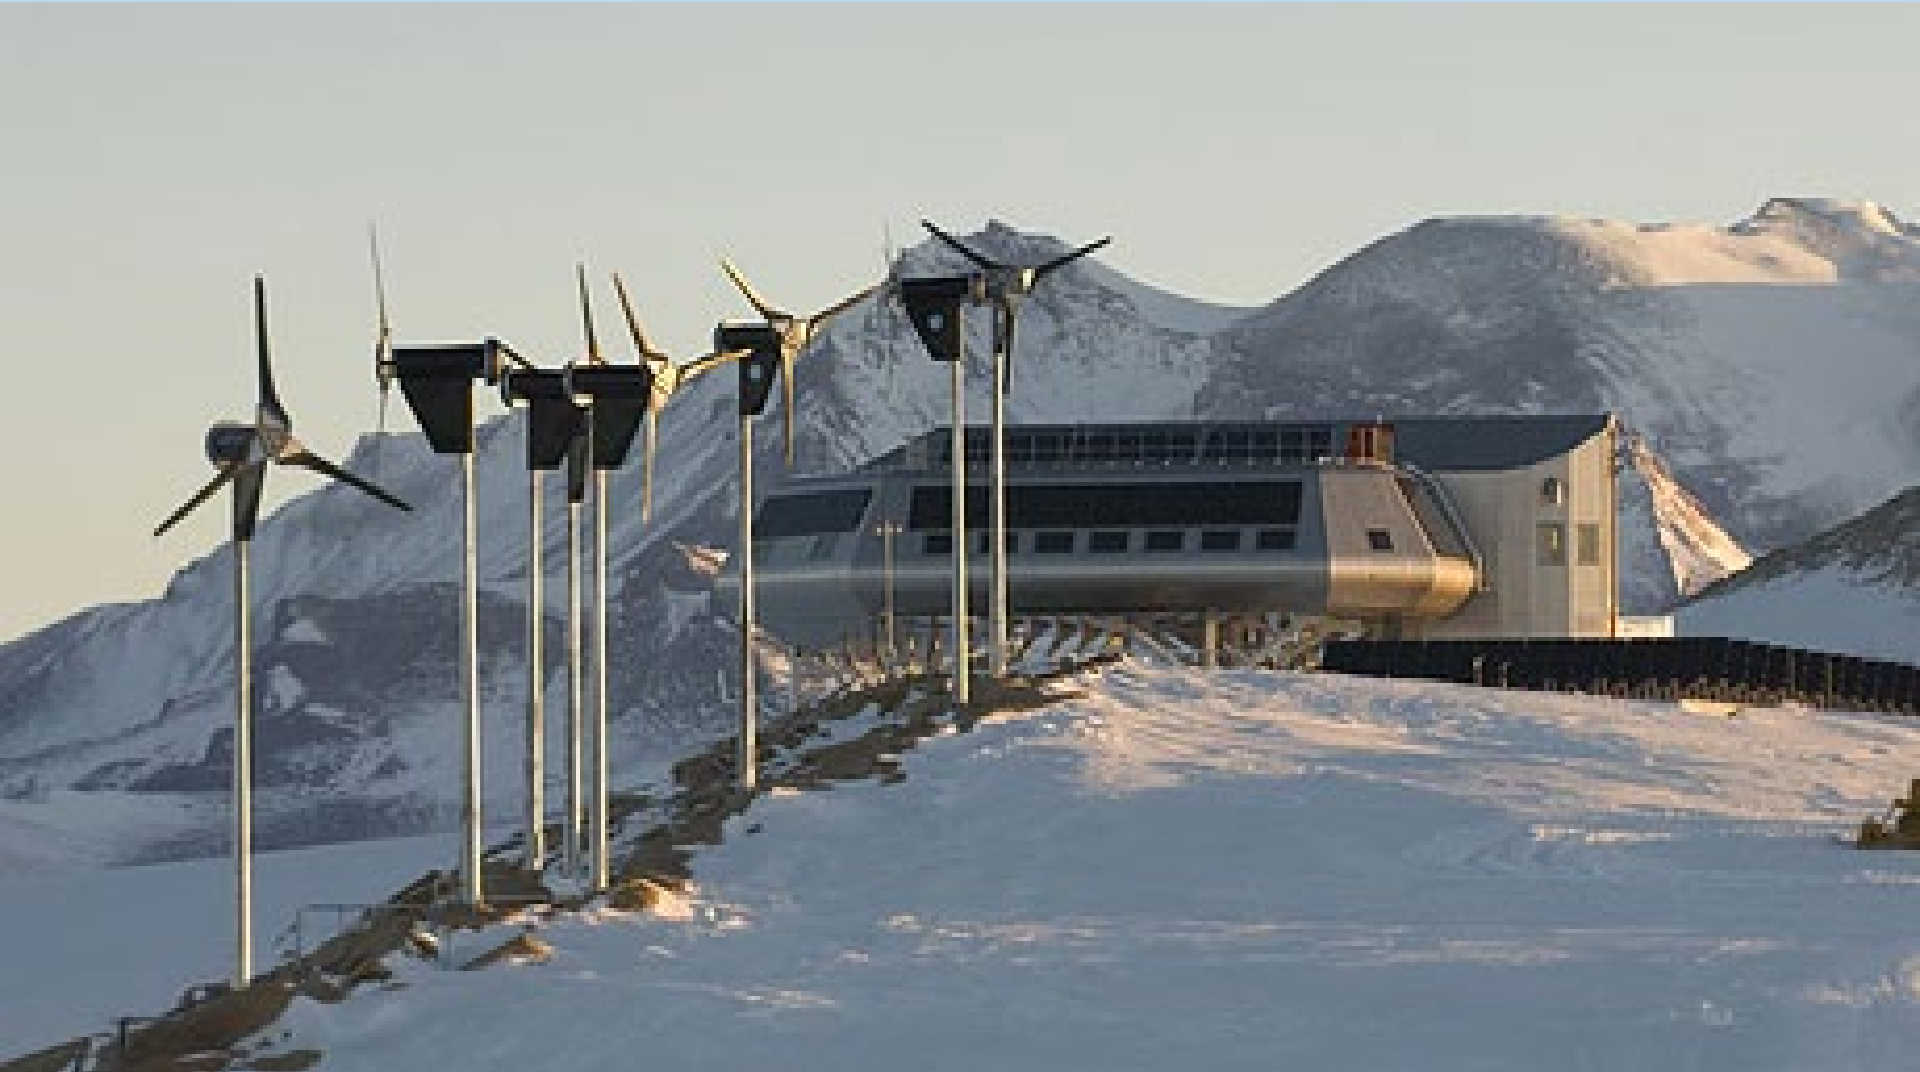
A zero-emission station, first of its kind: nine wind turbines, two types of solar panels, batteries to store excess power, and two generators as back up for emergencies

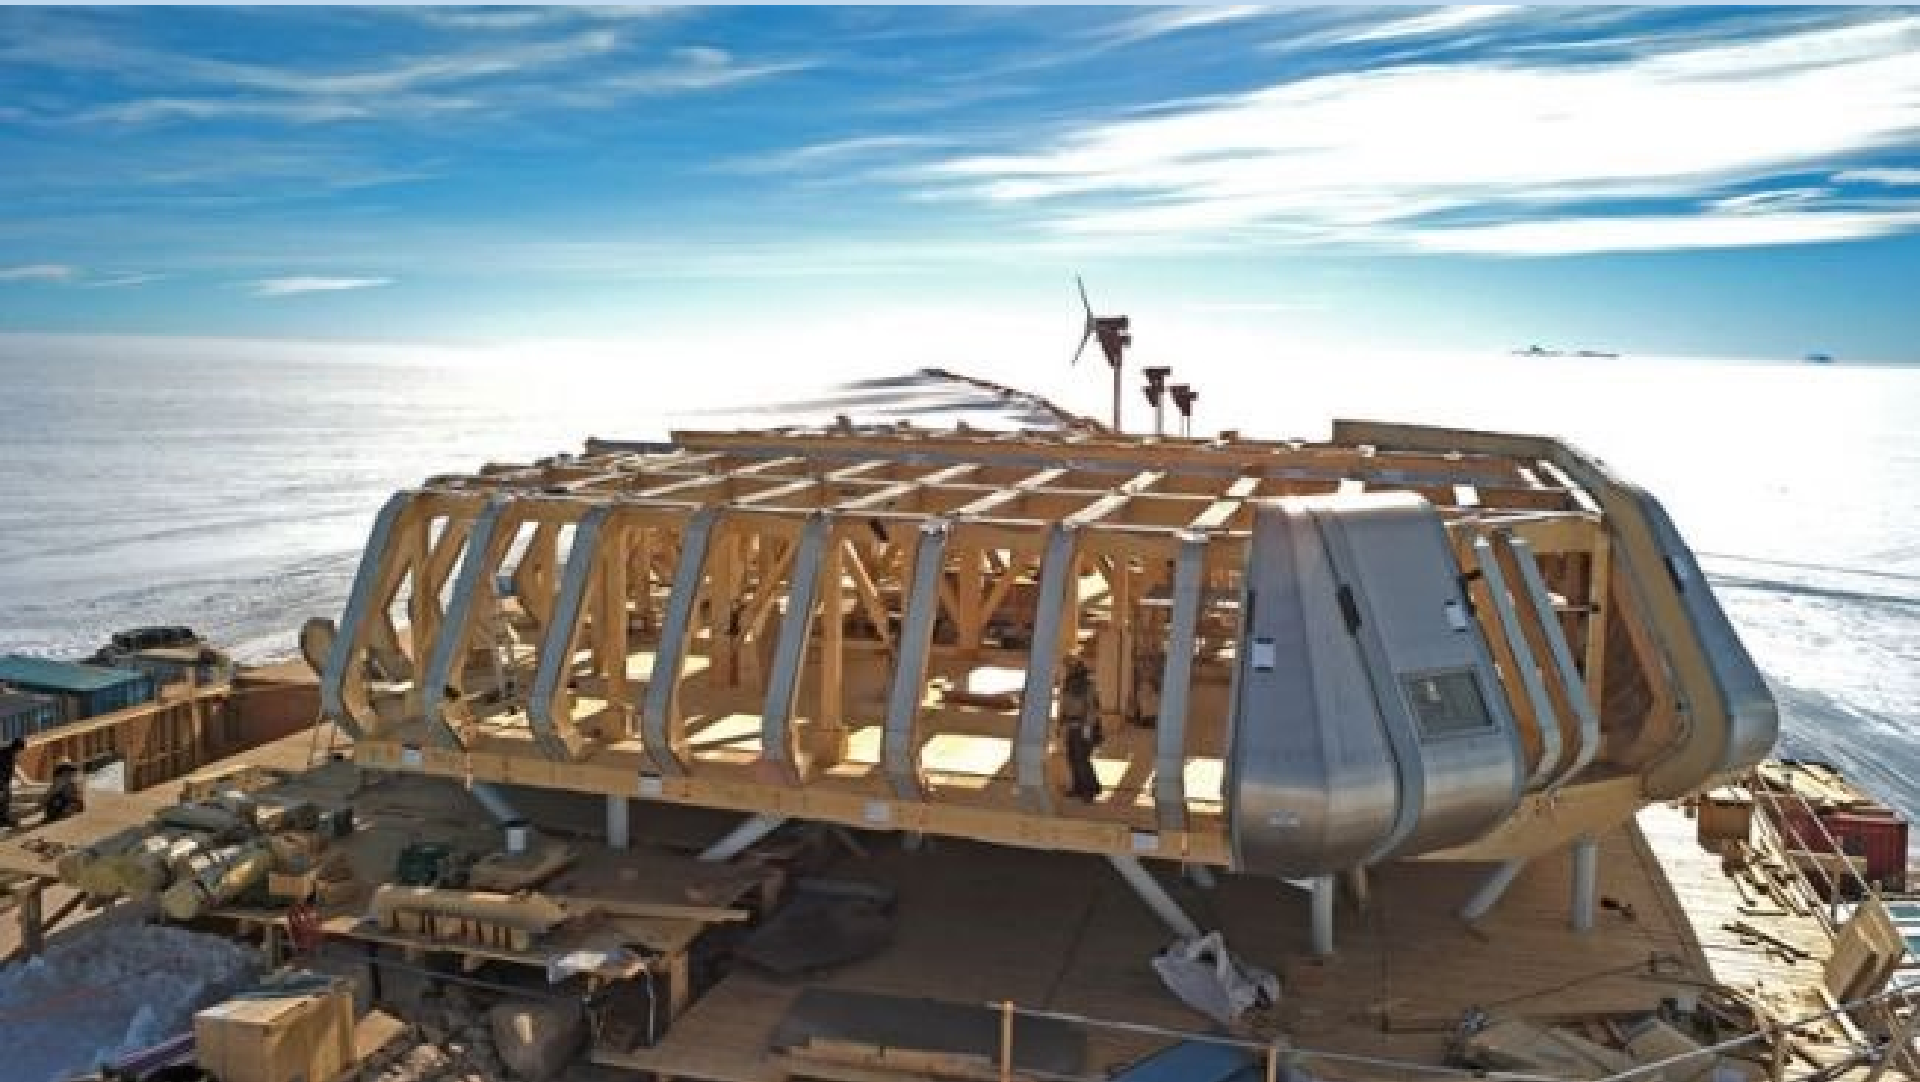
Built with steel anchoring on bedrock, wooden structure, wall modules with nine layers of wood, aluminum, felt, paper, insulation for minimal heat loss and also to be water and air tight

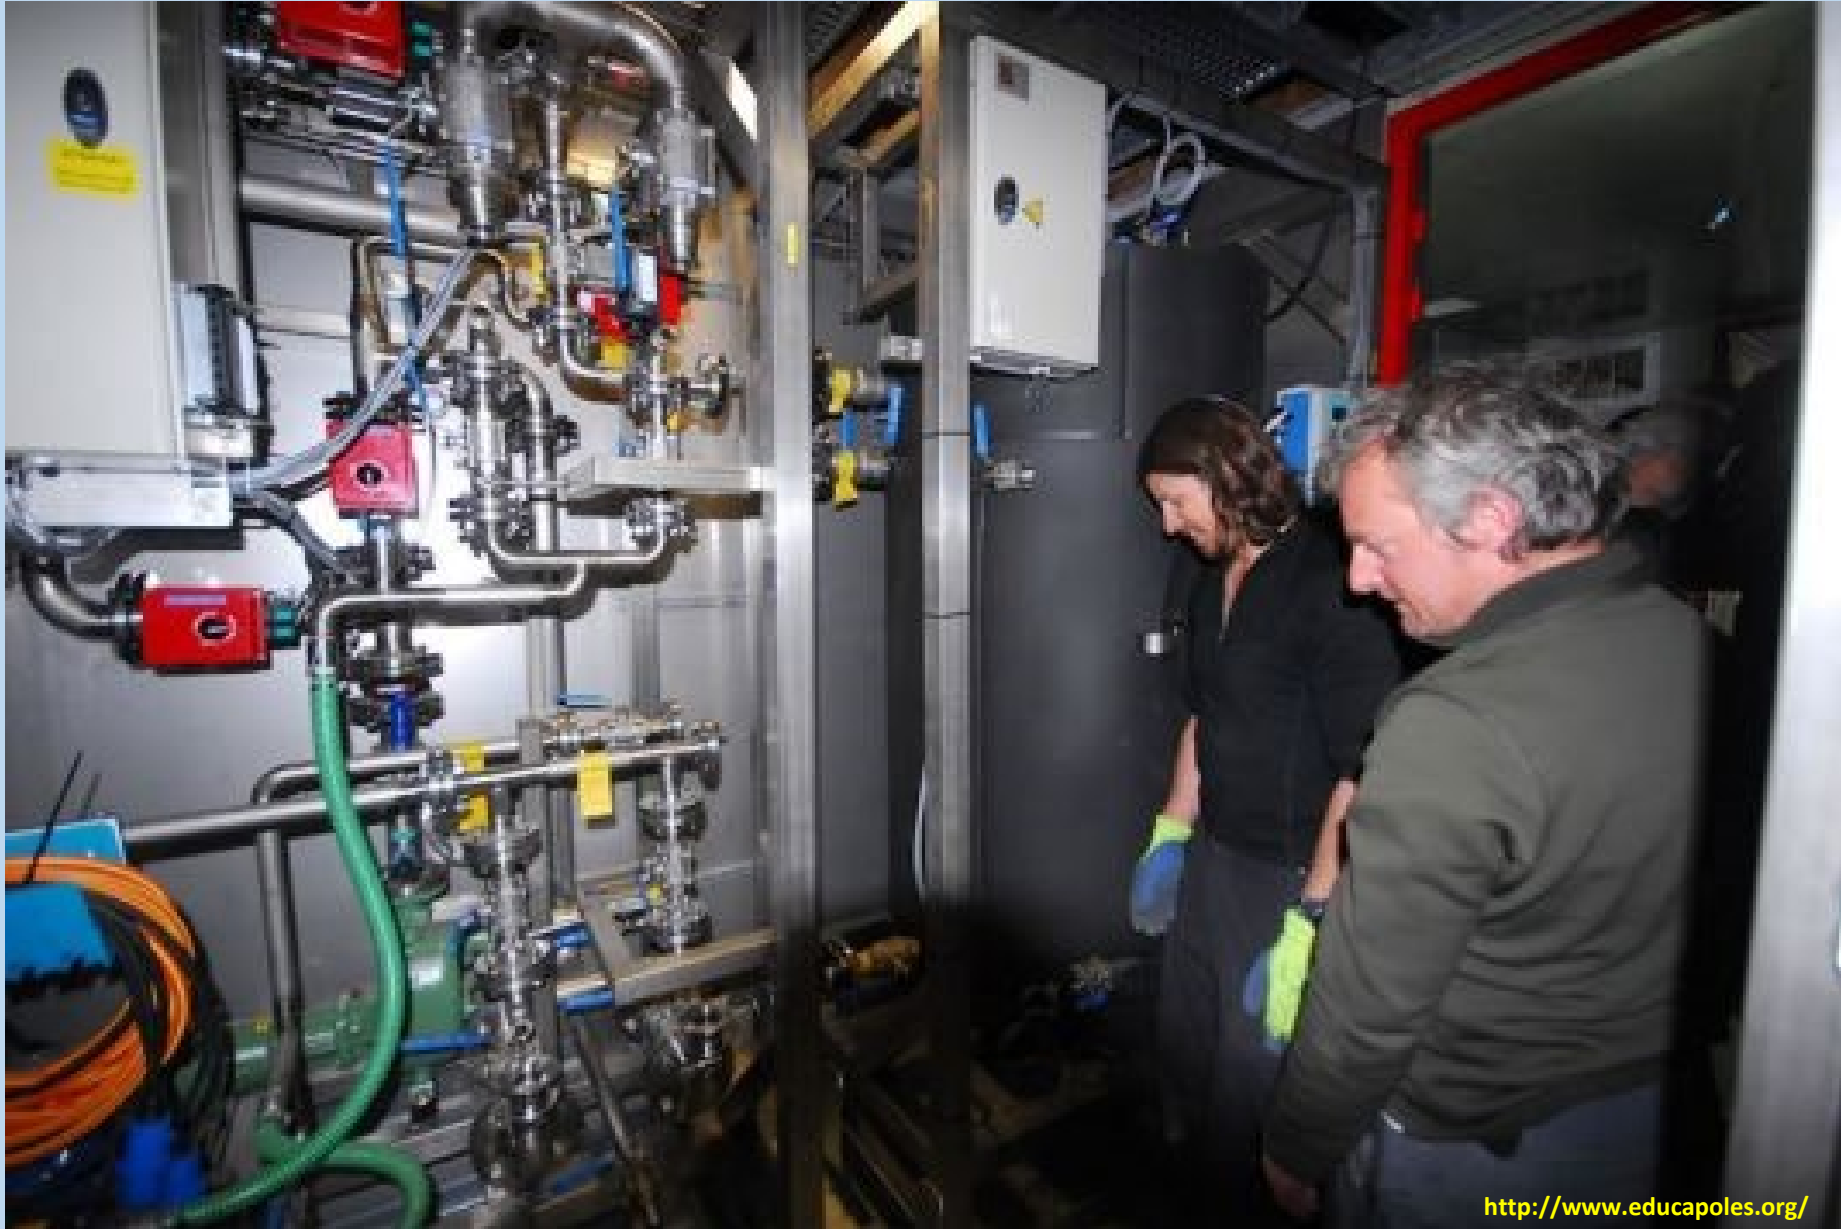
All water recycled, 75% reused including waste water that is purified

Water recycled five times, then disposed
