Figure Eight Island

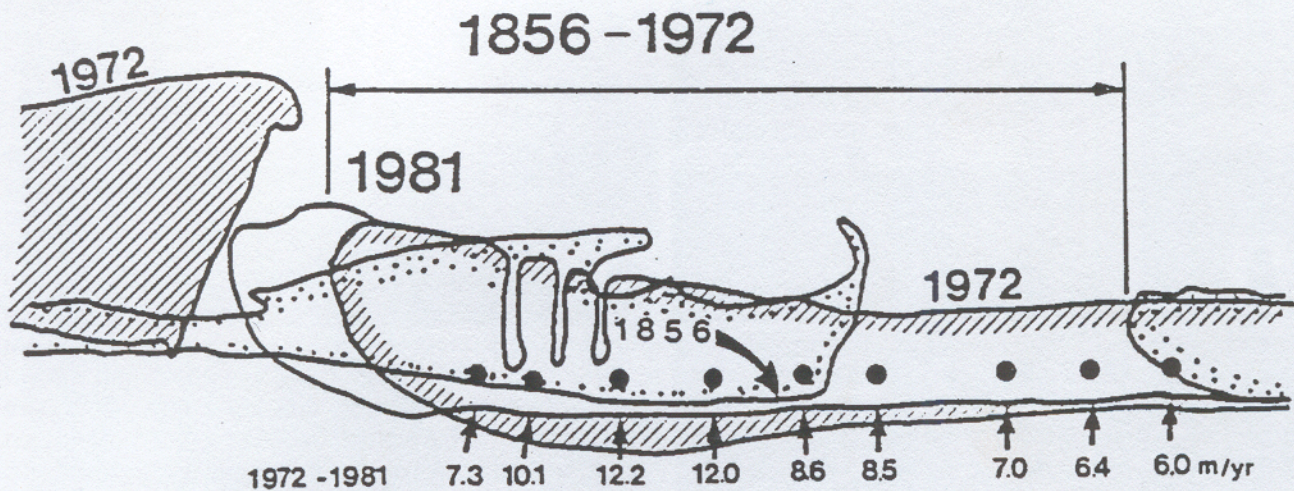
Dates	Amt.	Rate
1738 - 1986	9450 m	38 m/yr
1856 - 1963	2070 m	19 m/yr
1963 - 1981	680 m	34 m/yr

Figure 19. Shoreline erosion updrift of New Topsail Inlet. Cartoon depicts shoreline positions in 1972 and 1981, inlet position in 1856 and migration rates. Maximum erosion rates were recorded at the 1972 position of the shoreline bulge, north of the finger canals. Erosion is a result of planform adjustment (modified in part after USACE 1990 and Cleary 1994).

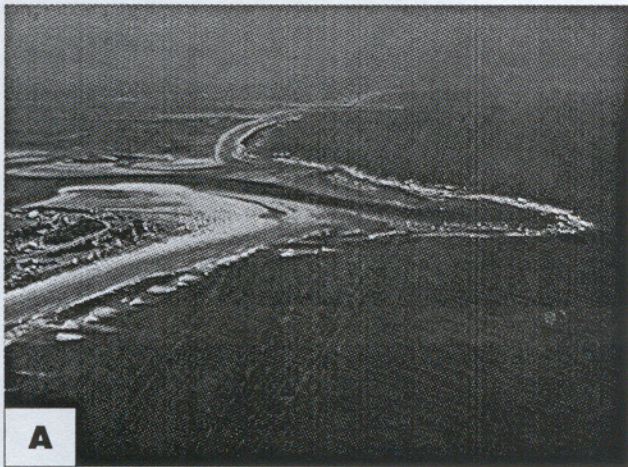
Figure 20. Figure Eight Island and adjacent inlets.

A. Rich Inlet, a stable inlet forms the northern border of Figure Eight Island.

Figure Eight Island is a narrow 6.5 km long island separated from Coke Island by Rich's Inlet and from Wrightsville Beach/Shell Island by Mason's Inlet (Fig. 20 A&B). The island exhibits two distinct physiographic sections. The northern half of the island is narrow, yet possesses a high, continuous, basically single, forested dune ridge. Toward Rich's Inlet, the island is offset seaward from Coke Island. The offset consists of a series of parallel dune ridges which undergo erosion or accretion as the ebb tidal shoals of Rich's Inlet change (Fig. 20 A). Rich's Inlet has shown little tendency to migrate, however, the cyclical re-orientation of the ebb channel can produce very rapid erosion on adjacent shorelines (Fig. 21).

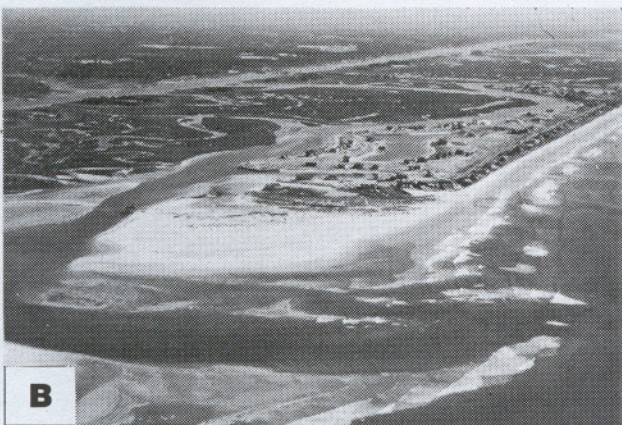
B. Mason's Inlet a small migrating system borders Figure Eight Island to the south. Note the straightened shoreline updrift of the inlet.

Several 'marsh islands' are evident in the lagoon behind Figure Eight Island (Fig. 20 B). These islands are characteristically narrow linear areas of higher elevation with the long axis of the island parallel to the seaward barrier island. These islands form landward of an inlet where flood tidal delta sands overtop the marsh. The higher ground is occupied by less salt tolerant plant species, including various shrubs and trees. As an inlet migrates and/or closes, a chain of islands is preserved within the marsh. Thus, these islands can be used as indicators of the location of historic inlets in areas where lagoons are infilled with marsh. Several good examples of marsh islands are found in the lagoon behind Figure Eight Island.

The southern section of Figure Eight Island exhibits a generally low, washover, inlet-influenced shoreline (Fig. 20 B). A large recurved foredune marks the historic northern limit of Mason's Inlet. Sequential aerial photographs show that the inlet has migrated more than 1100 m since 1938. Before construction of homes began along this section of the island in 1970, sand dredged from the sound side of the island was deposited on the berm. Erosion along the southern half of the island was inconsequential until Mason's Inlet re-initiated a rapid migration to the south. Similar to events at Topsail Island, migration of the ebb channel of Mason's Inlet removed protecting bars of the ebb delta and exposed the southernmost section

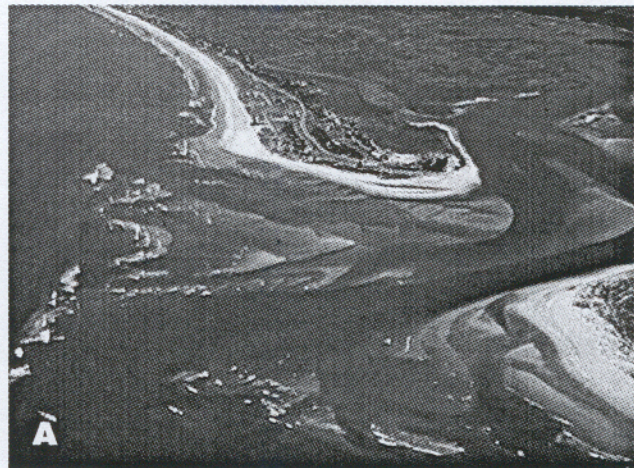
Figure 21. Rich Inlet Erosion.

A. Ebb channel is shore-normal and flanked by wide flood channel on Figure Eight shoulder. Encroachment of marginal flood channel onto south shoulder is prompted by deflection of ebb channel.

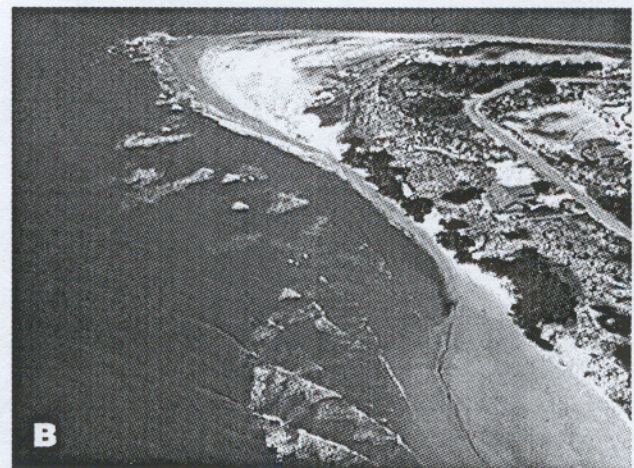
B. Welding and migration of attached bars produced temporary erosion in lee of sand bar. Sand packet eventually moves into estuary and accretion commences. Erosion rates were as high as 2m / day for a six week time period in mid 1984. Area is now fronted by a 200 m wide intertidal beach.
